LEVEL THREE

Your survey report

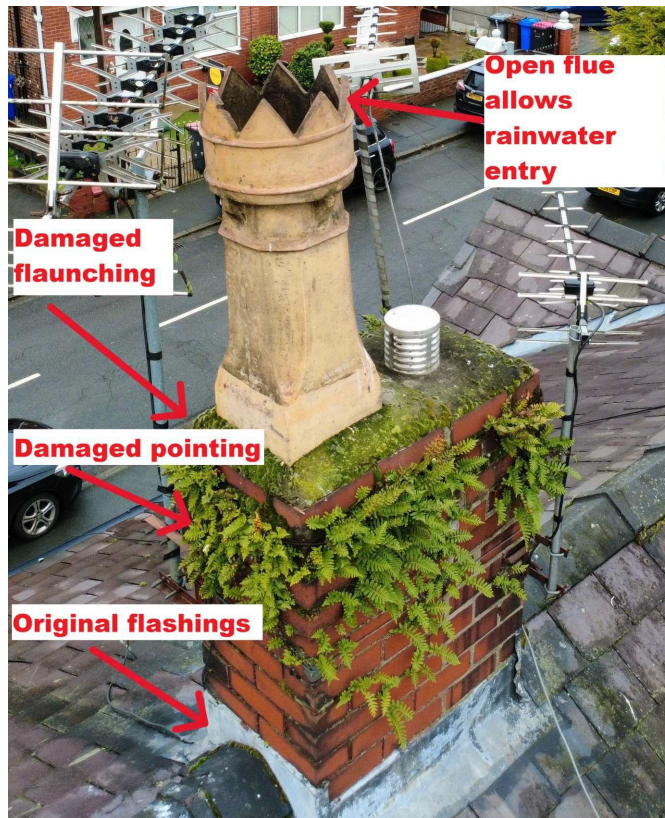
We noted heavy vegetation growth to the pointing all around the stack. We would recommend that the repointing is repaired within the next couple of years to prevent water penetration into the roofspace. We noted dark staining to brickwork chimney breast in the roofspace indicating damp penetration.

Chimney stack viewed from a drone at the rear

Element no.	Element name	Comments (if applicable)
D1	Chimney stacks	We would recommend that the flue is capped and vented, the chimney stack is overhauled including repairing any cracked sand/cement flashing, removing vegetation and repointing the brickwork. The flashings should be replaced when the roof is recovered.
D2	Roof coverings	We would recommend that urgent repairs are undertaken as soon as possible such as replacing any loose/missing tiles and repointing/re-bedding the ridge tiles. And allowance to replace the main pitch coverings is made within the next 10-15 years.
D3	Rainwater pipes and gutters	Undertake maintenance to rainwater goods, refix front gutters to suitable falls, clean out RWO.
E1	Roof structure	A structural engineer should assess the extent of the damage. The rafter will likely need reinforcement (such as sistering or steel plating), and the pipework should be rerouted so it no longer passes through structural timbers. Any associated moisture damage should also be checked and addressed. The cut-rafter roof structure with purlin support shows several defects, including dampness to the party wall, daylight visible through gaps in the roof covering, the absence of an underlay. Repairs are recommended to close gaps in the covering, investigate and remedy the source of dampness, and upgrade the insulation. The electrical wiring present in the roof space should also be reviewed by a qualified electrician. Based on both internal and external condition indicators, it is likely that the roof covering will require replacement within the next 10–15 years, and potentially sooner if defects worsen or water ingress becomes more significant.

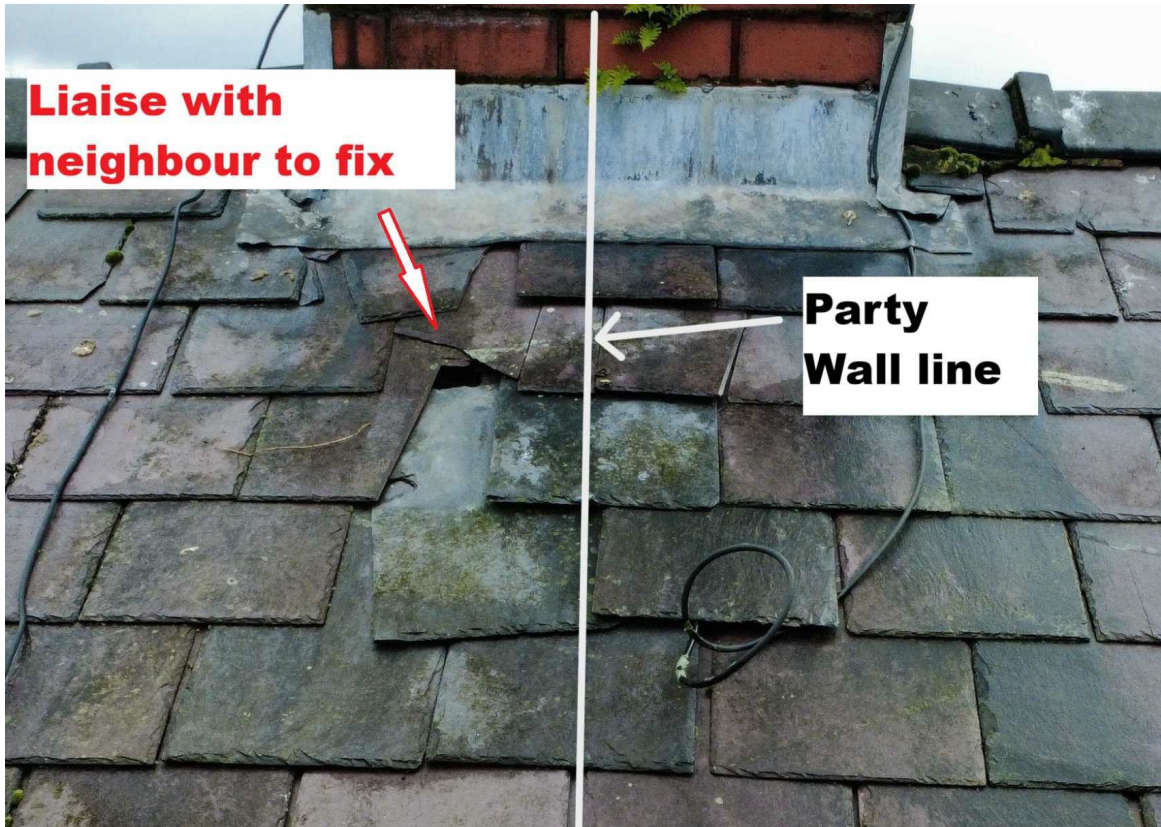
Note the position of the hole to the front

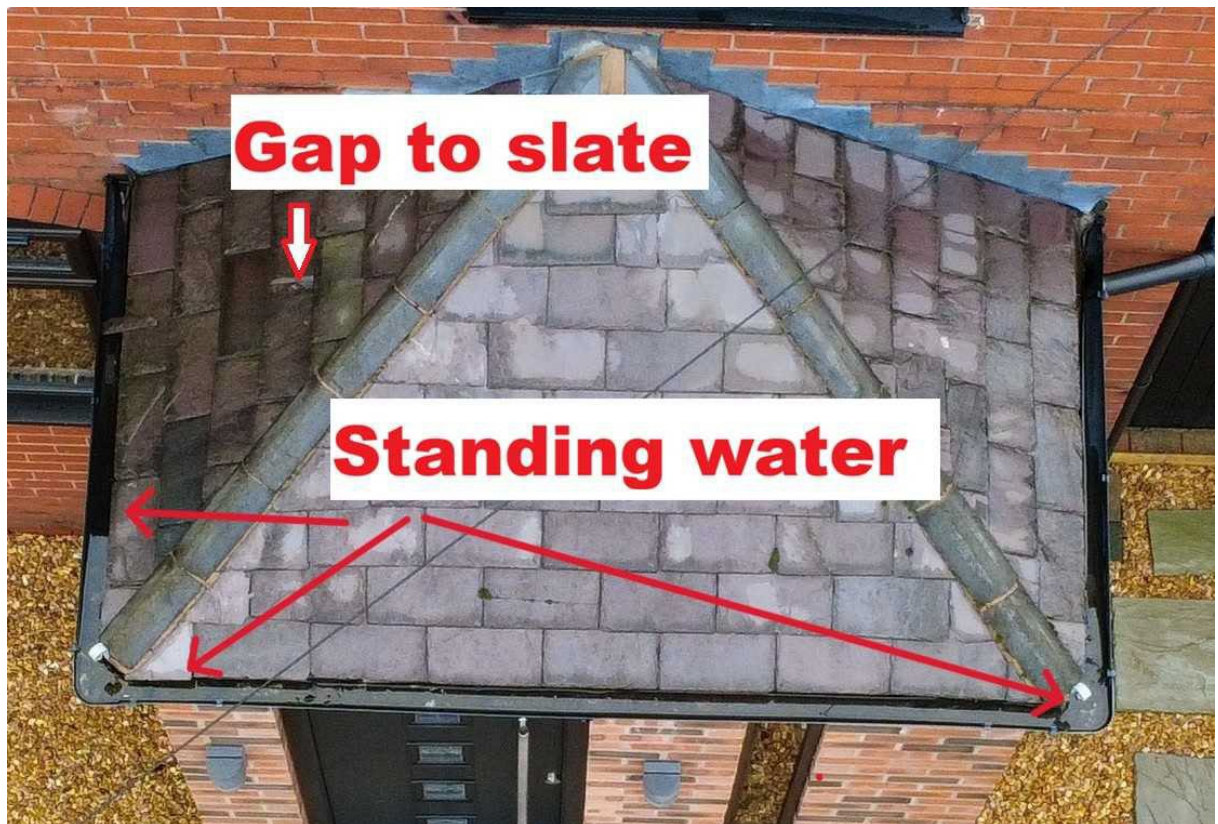
The roof covering to the front porch requires some minor repairs as can be seen from the labelled photos.

Porch roof

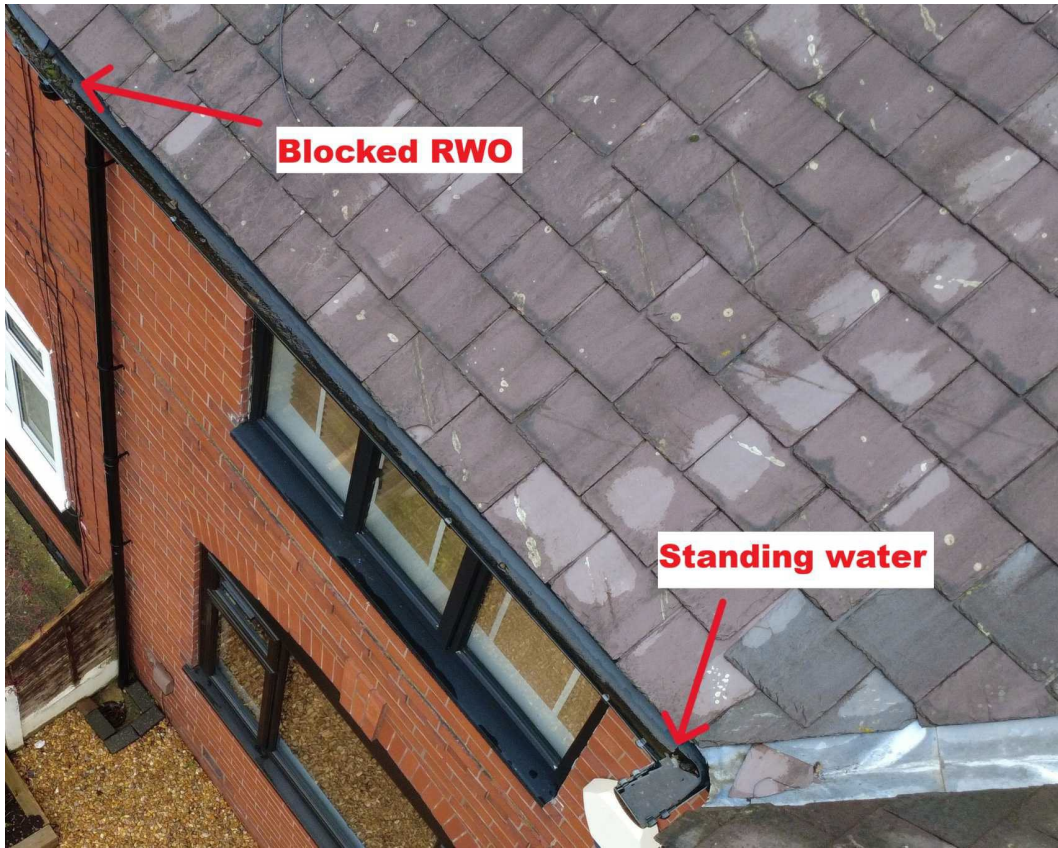
We noted standing water in the guttering at the front of the property, which overflows as evident from the staining on the base of the front wall. There is debris blocking the front rainwater outlet. The porch roof guttering has also poor falls, which is evident by the standing water.

Main roof front guttering

Drainage gullies should be cleaned and maintained regularly to minimise the risk of blockage and as a precaution all surface water gullies and drainage trenches within curtilage should be flooded prior to purchase commitment to determine their likely adequacy or otherwise.

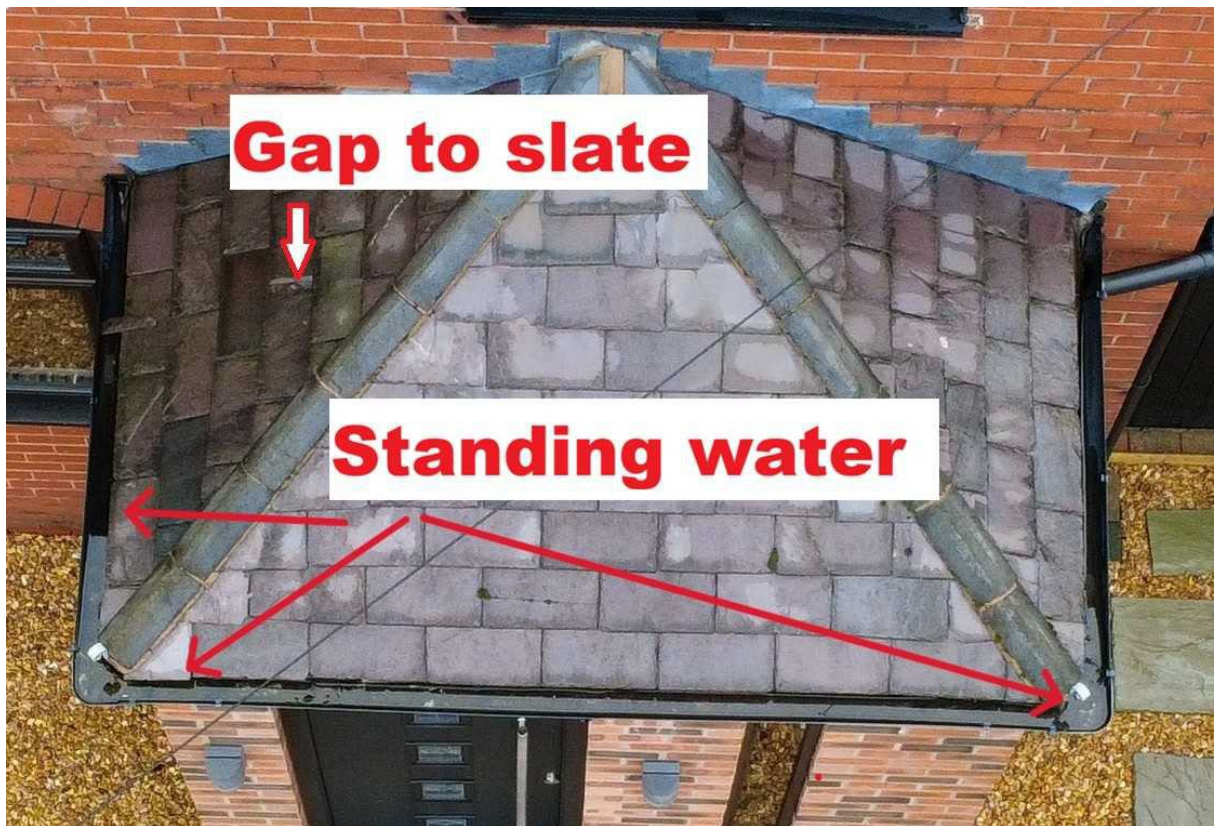
Porch roof

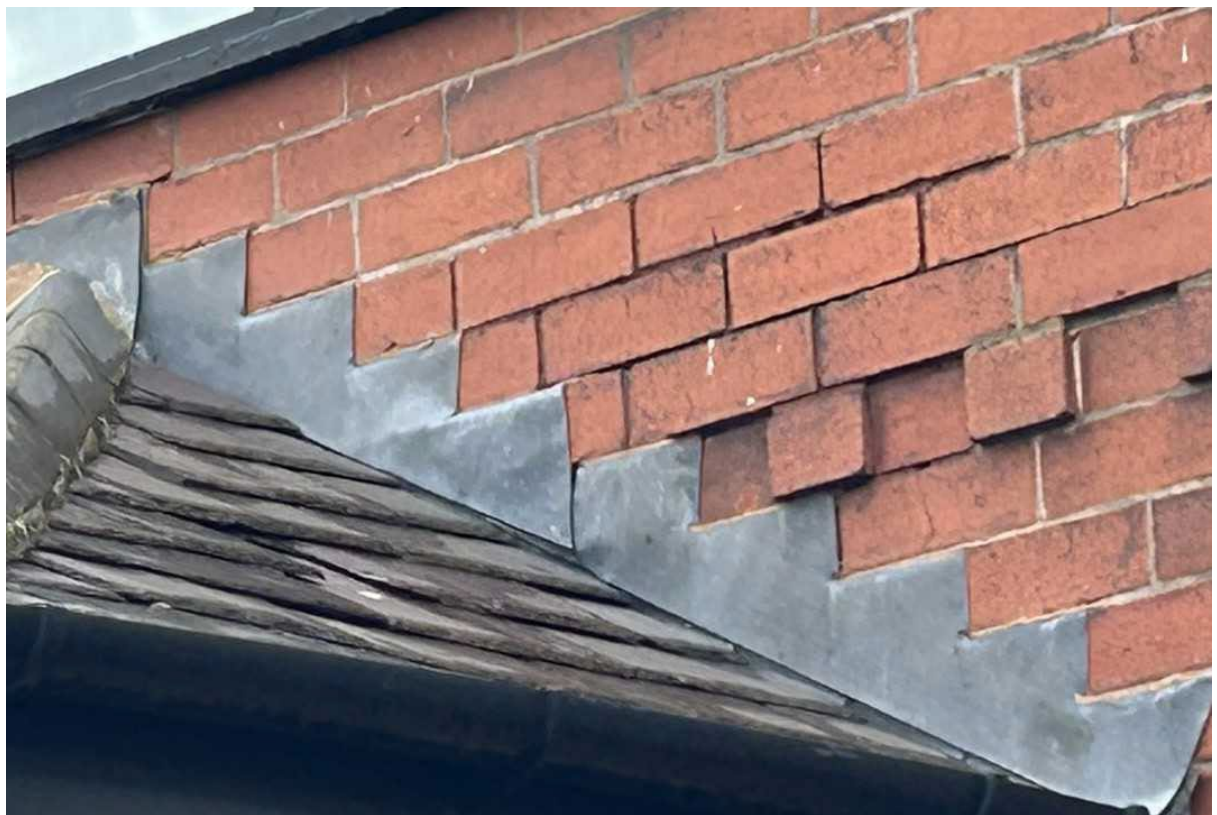
View to gaps to pointing above porch

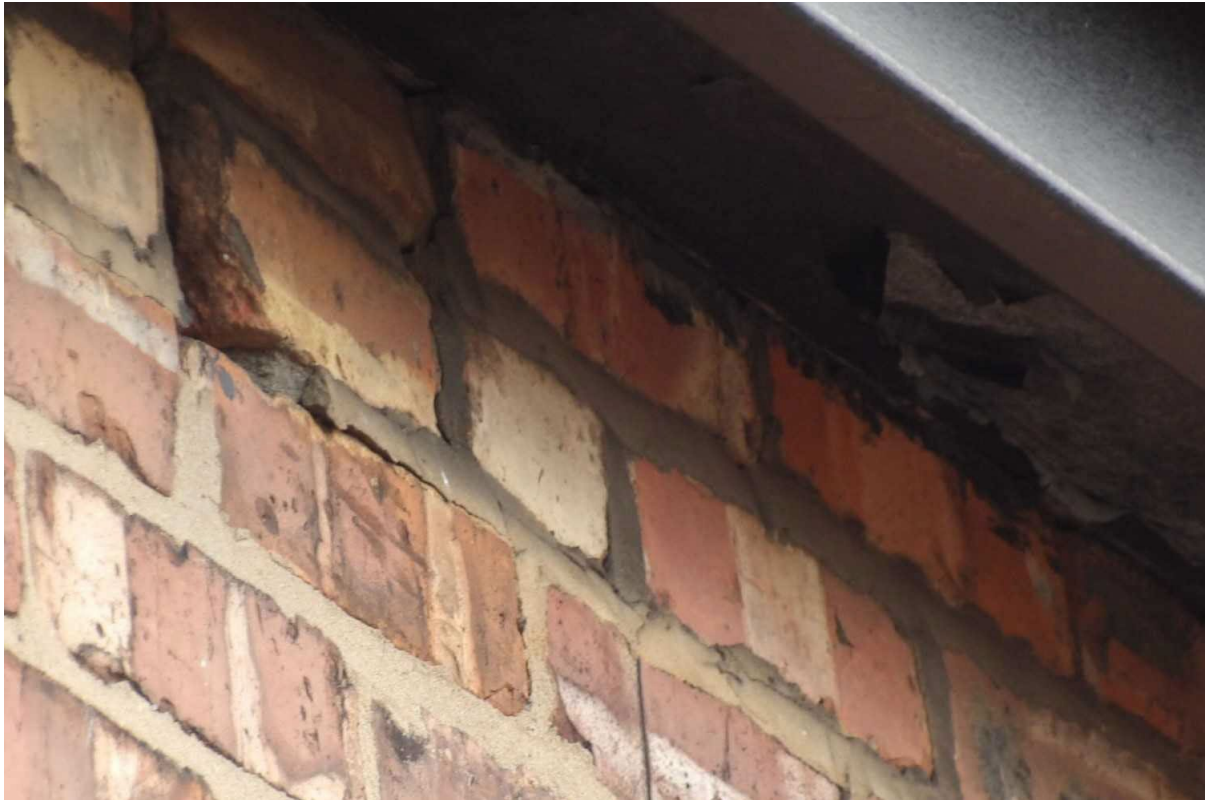
View to damage brickwork to gable

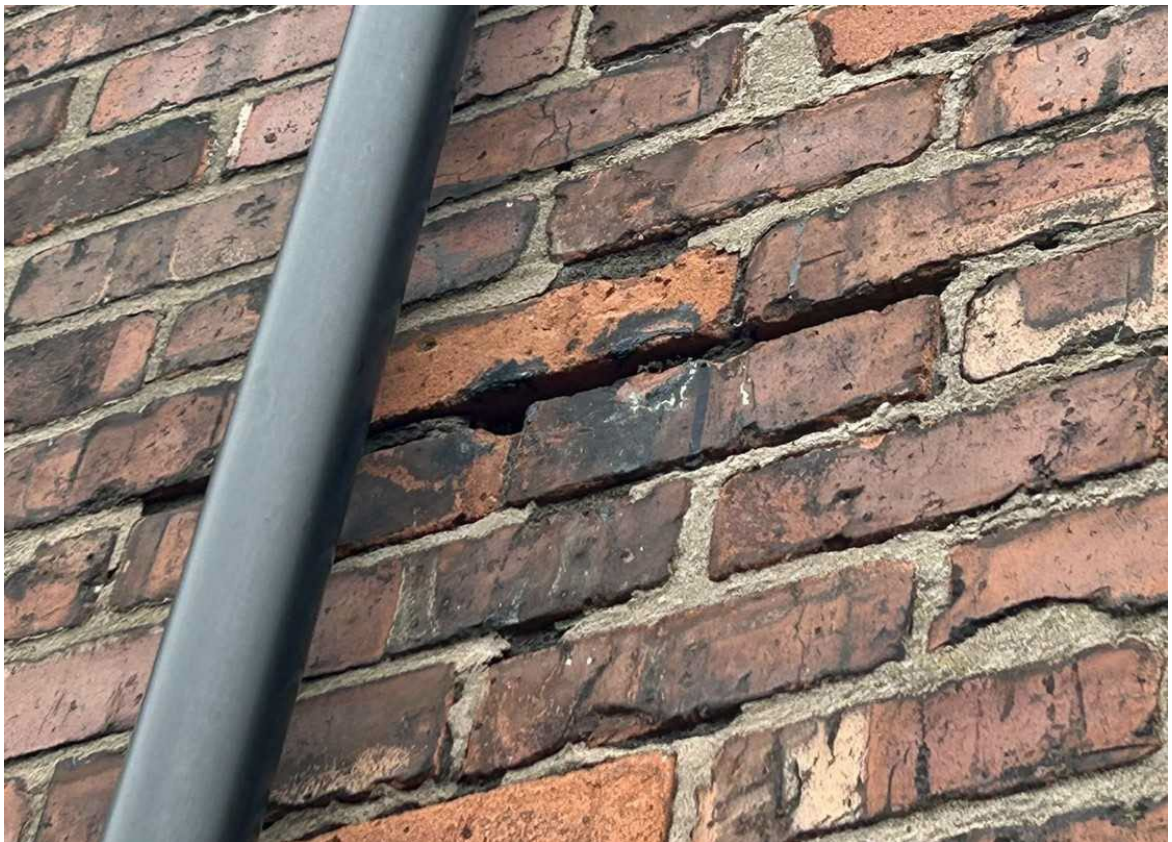
View to typical gaps to brickwork to gable

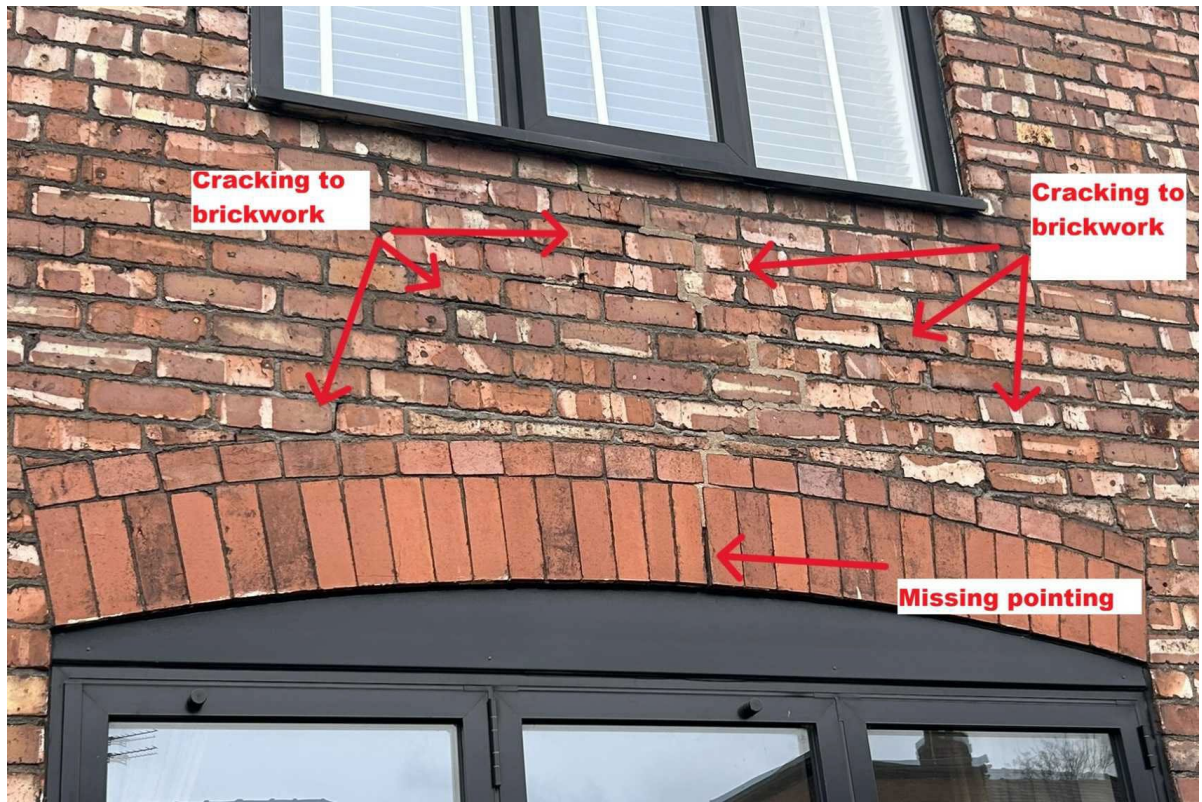
View to rear brickwork cracking above patio door

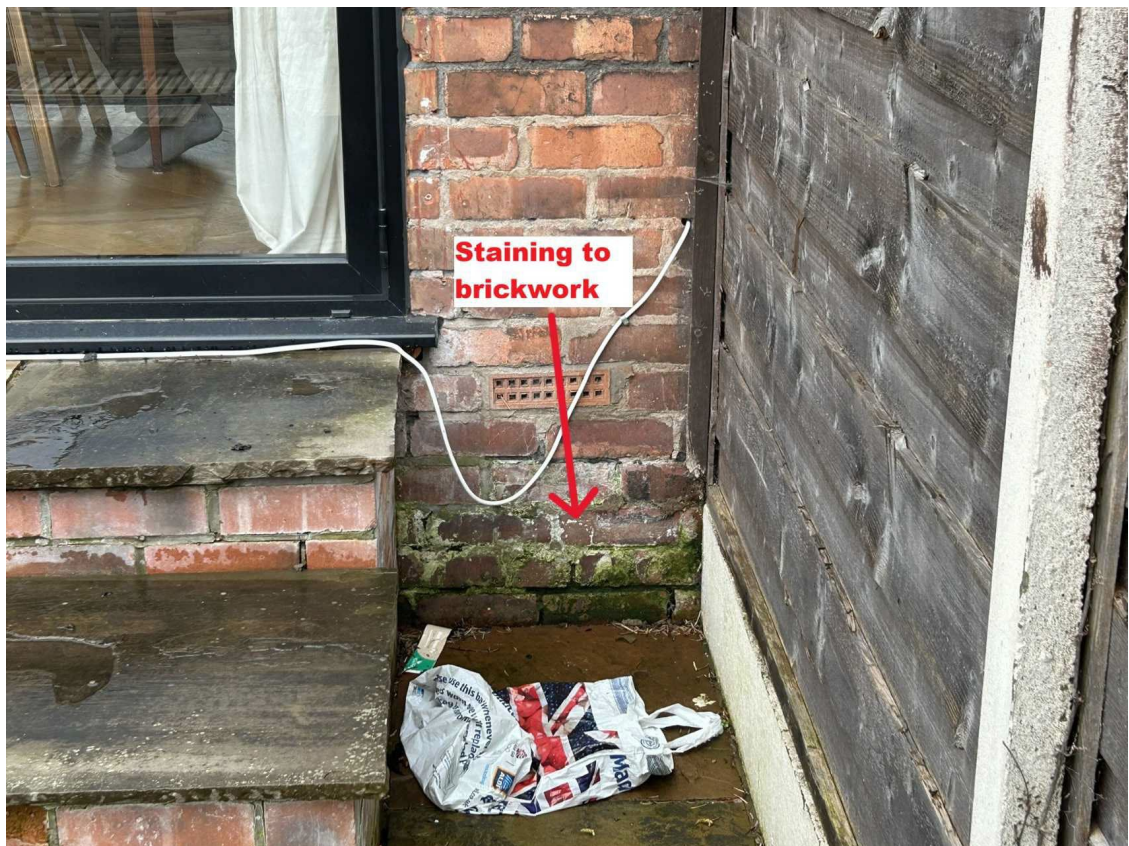
There was some localised staining to low-level brickwork, this appears to be due to leaking guttering (front) and/or ponding water to the paving (rear).

View to staining due to water ponding to paving

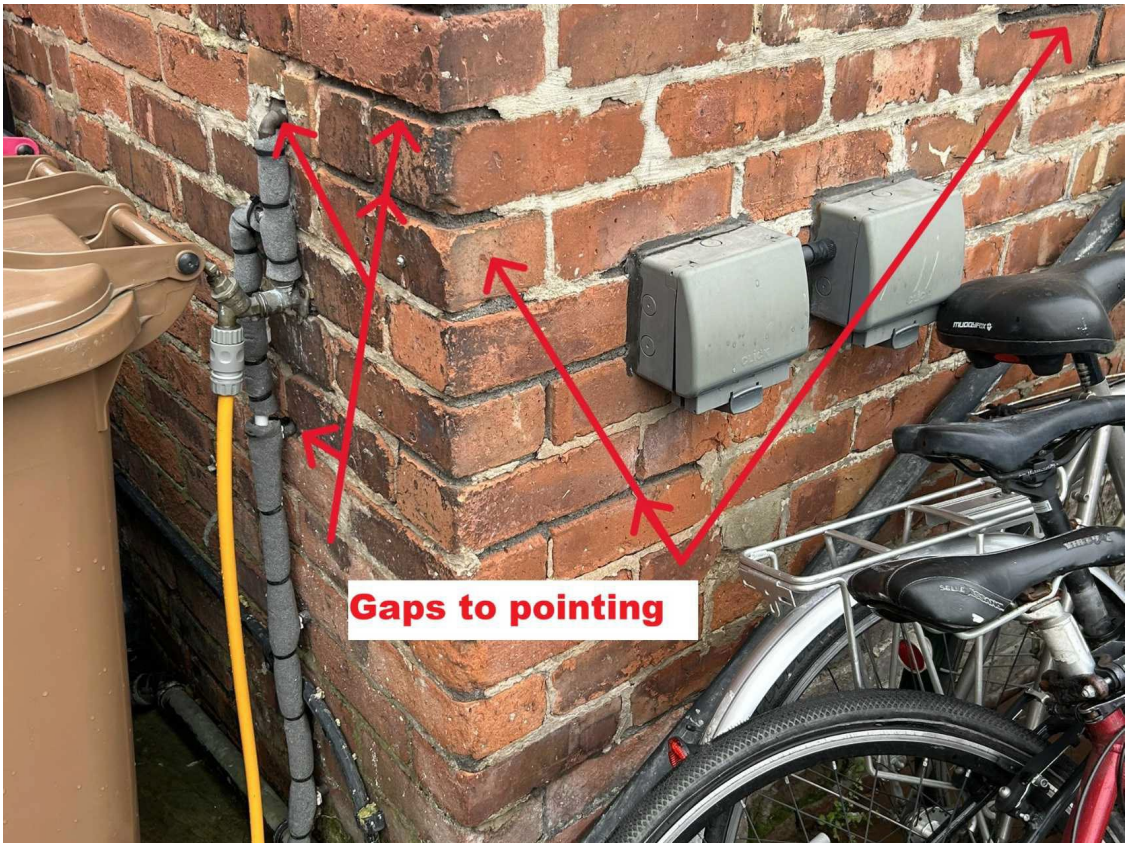
Gaps to point, rear low level

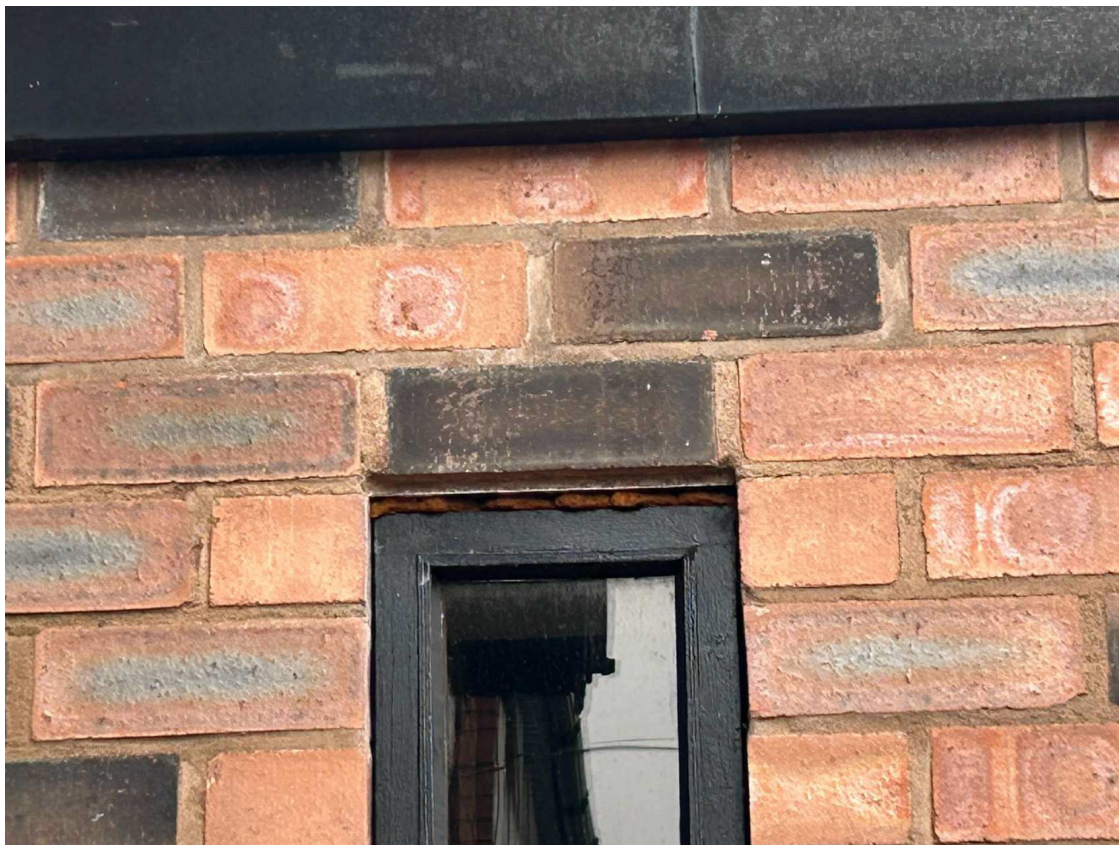
Typical window to porch, missing sealant

Element no.	Element name	Comments (if applicable)
D5	Windows	Allow to overhaul windows ironmongery. There are gaps to the sealant on the main building and sealant missing to the porch windows. We would recommend that all defective sealant is removed and replaced to prevent water penetration around the frame.
D6	Outside doors	There is a missing sealant to the porch door. We would recommend that all missing sealant replaced to prevent water penetration around the frame.
D7	Conservatory and porches	Refer to previous sections.
D8	Other joinery and finishes	External decorations, such as repainting woodwork and inspecting uPVC components for damage, should be carried out as required, about every five years, to ensure that all surfaces are protected.
D9	Other outside the property	Allow to undertake investigations and repairs as recommended to prevent moisture transfer internally to the lounge area.
E2	Ceilings	As with the majority of plastered ceilings, minor areas of deterioration to the plaster do exist, in particular where surfaces meet. This is to be expected and can be rectified when attending to redecoration. We tested the ceilings for damp in various areas and no high readings were recorded.

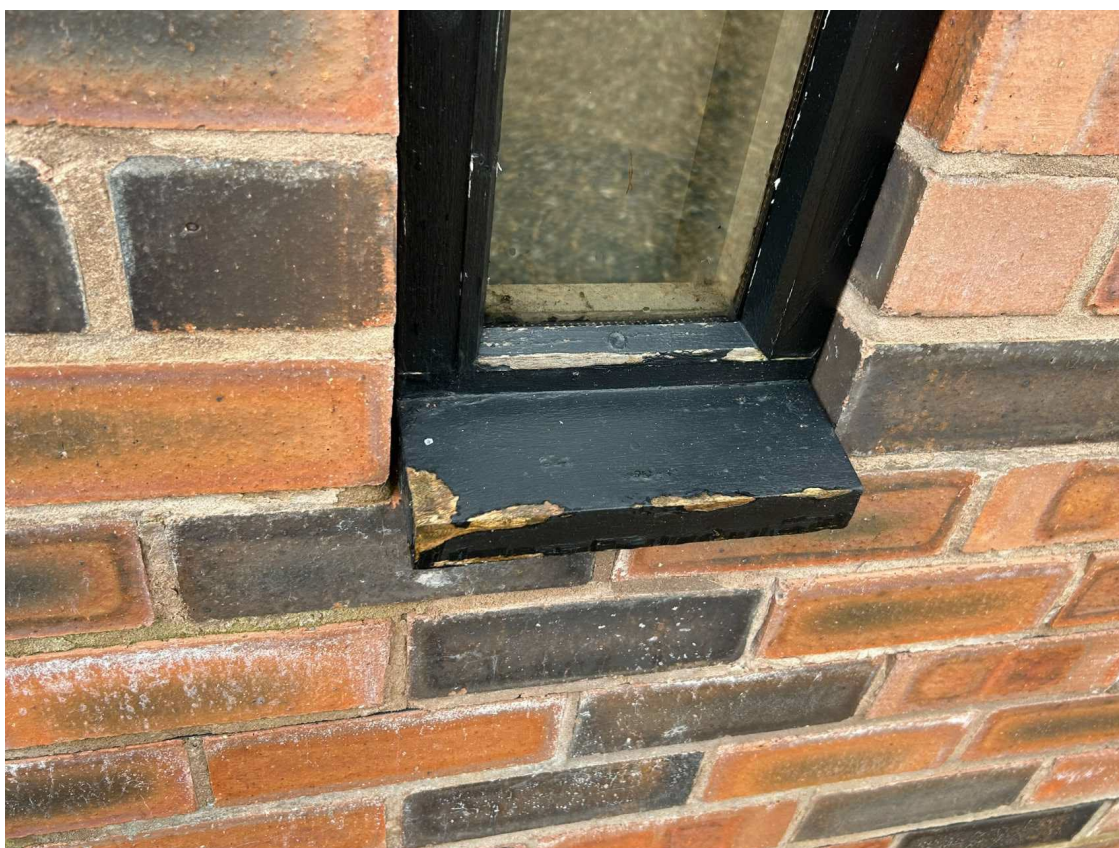
Porch window, damage to cill.

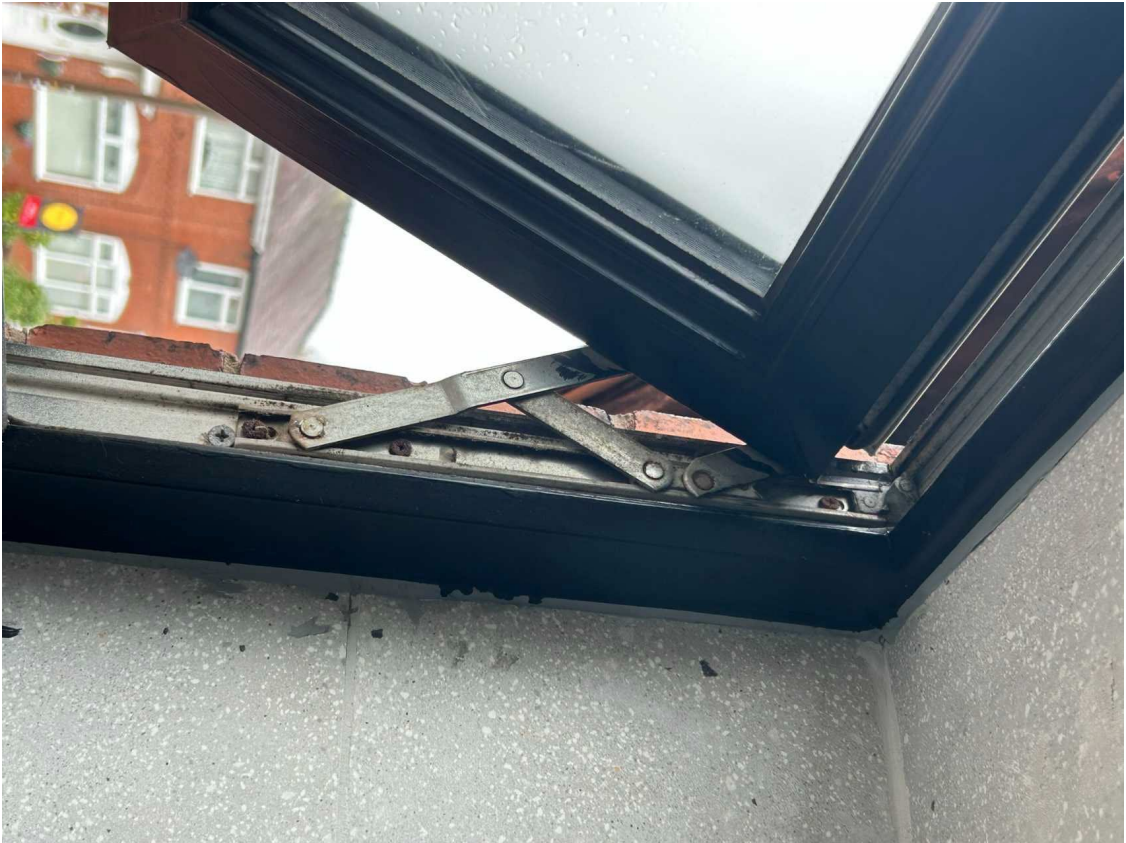
Ironmongery- corroded

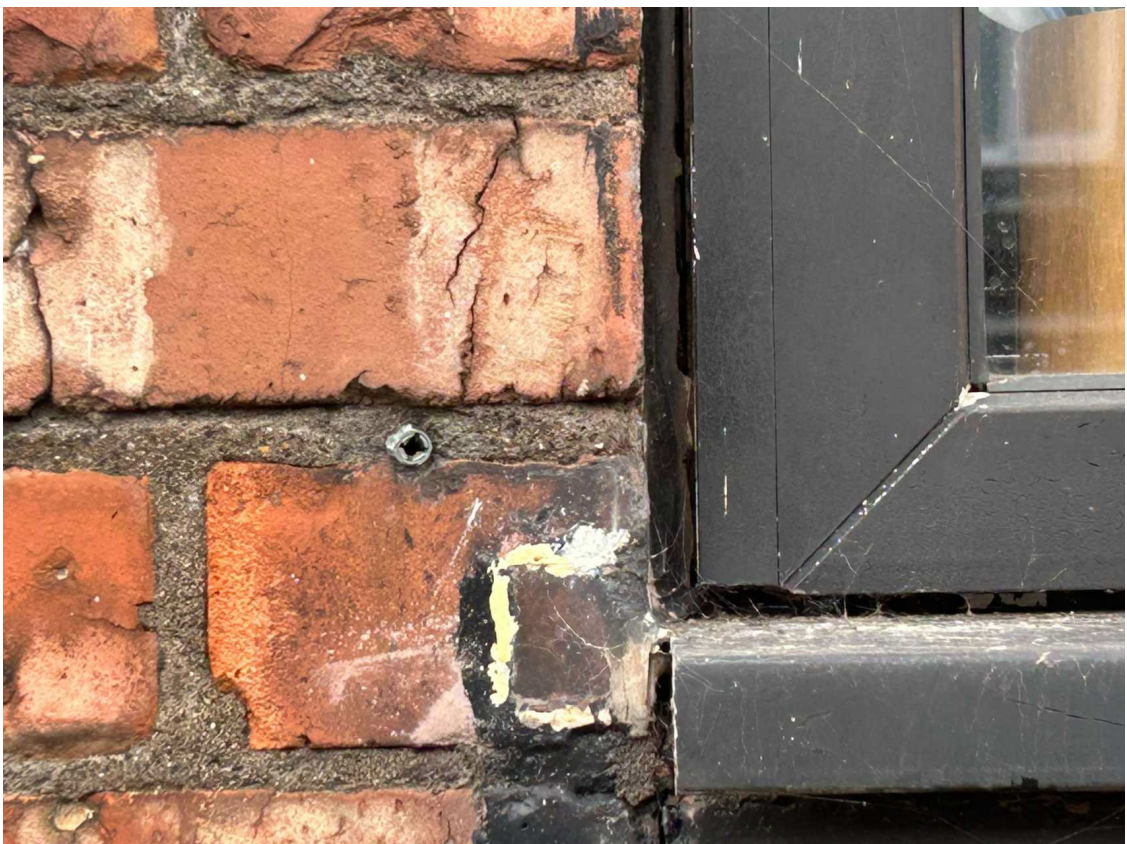
Gap to sealant- rear windows

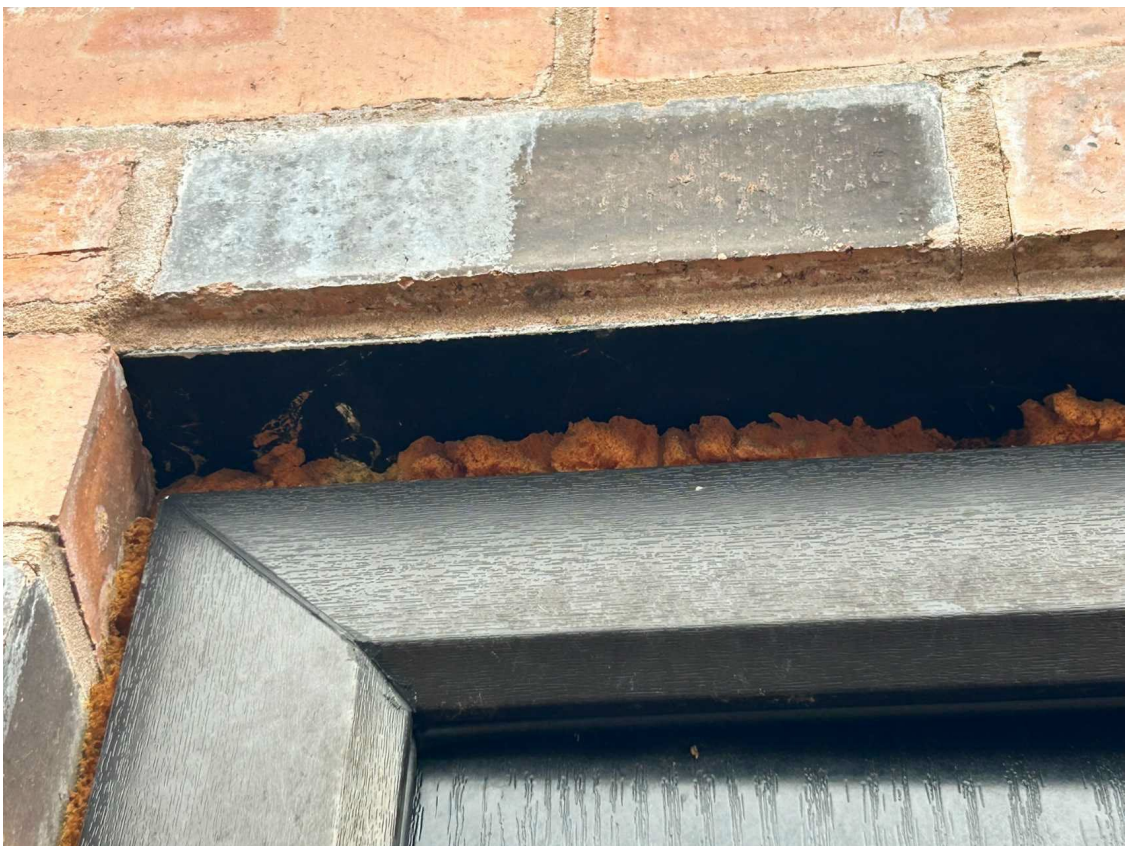
Missing sealant to front door

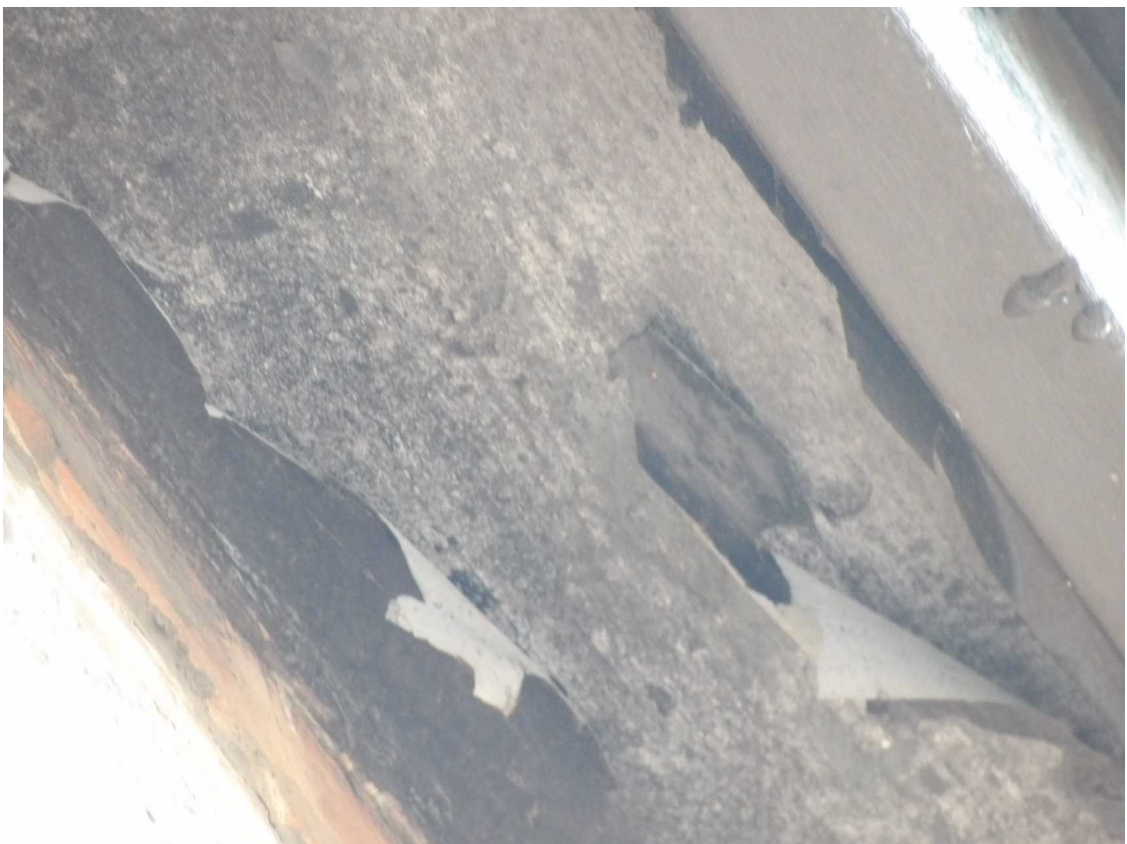
Peeling paintwork to soffit on the right hand side

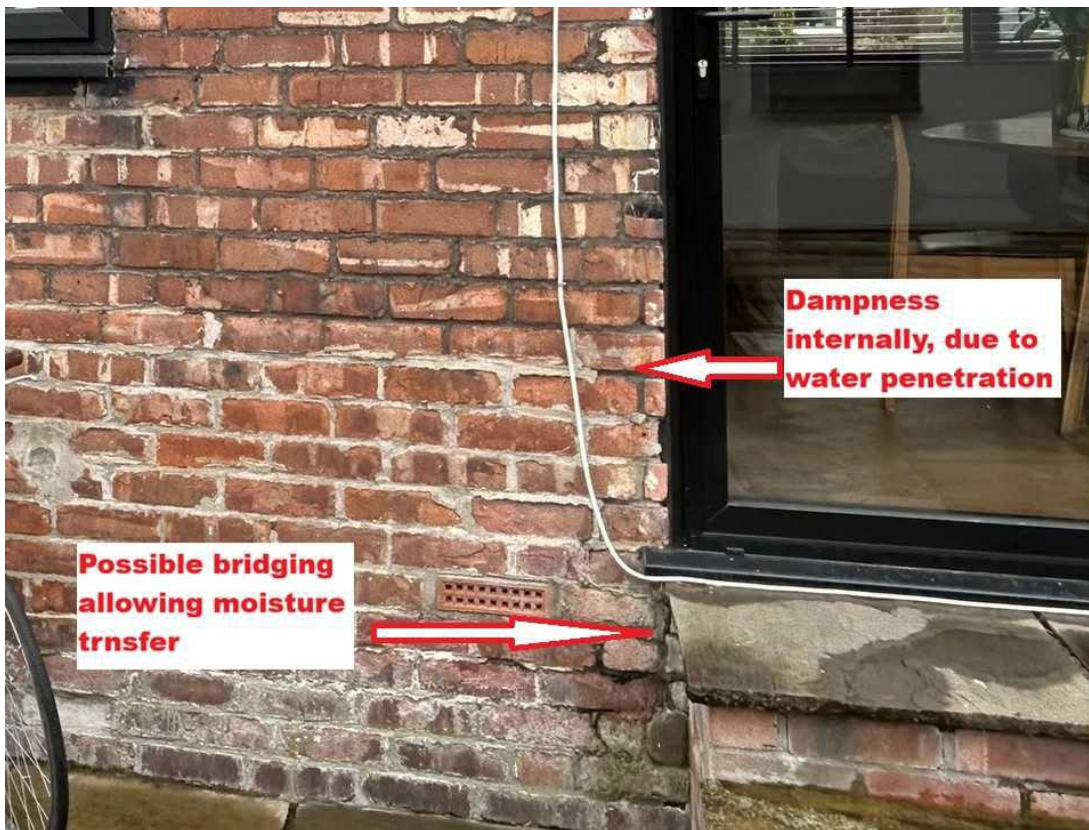
Moisture is entering through the external brickwork around the window, leading to internal damp patches.

Check the stepped area to confirm and allow the insertion of a vertical DPC to prevent moisture transfer.

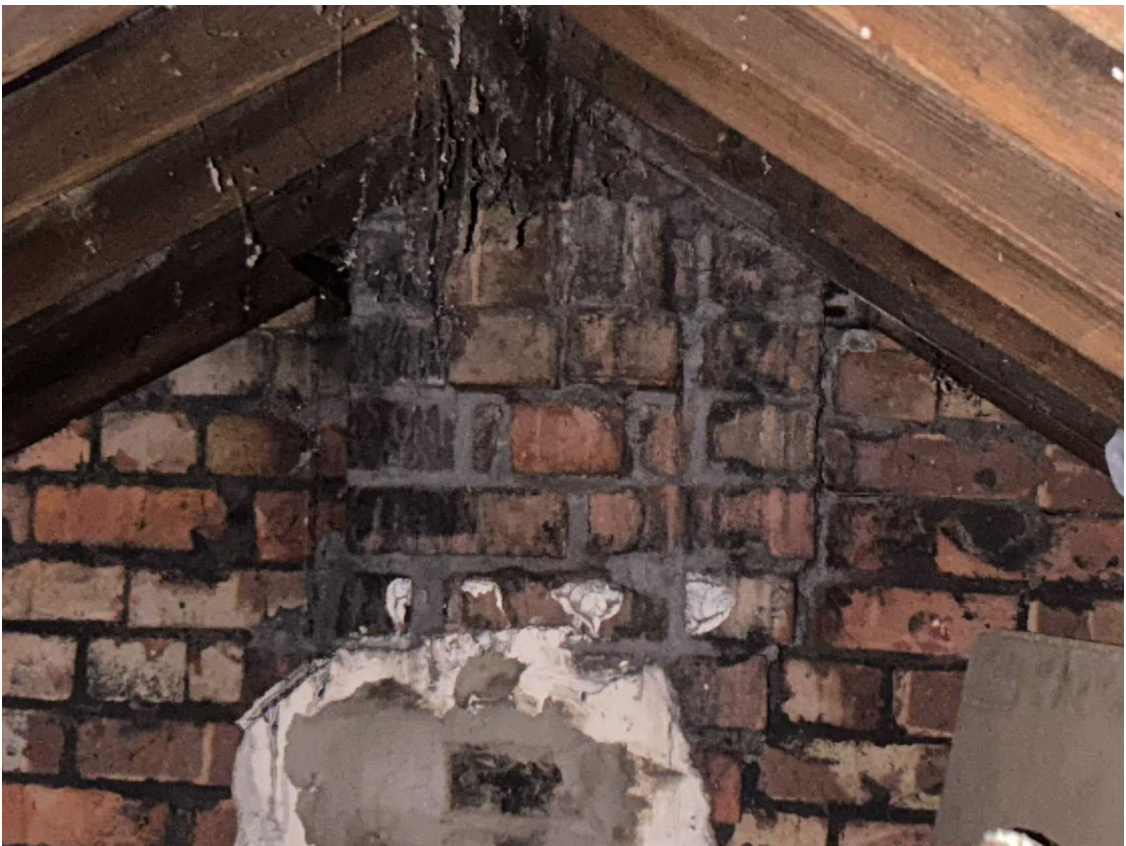
View to party wall - staining to chimney breast

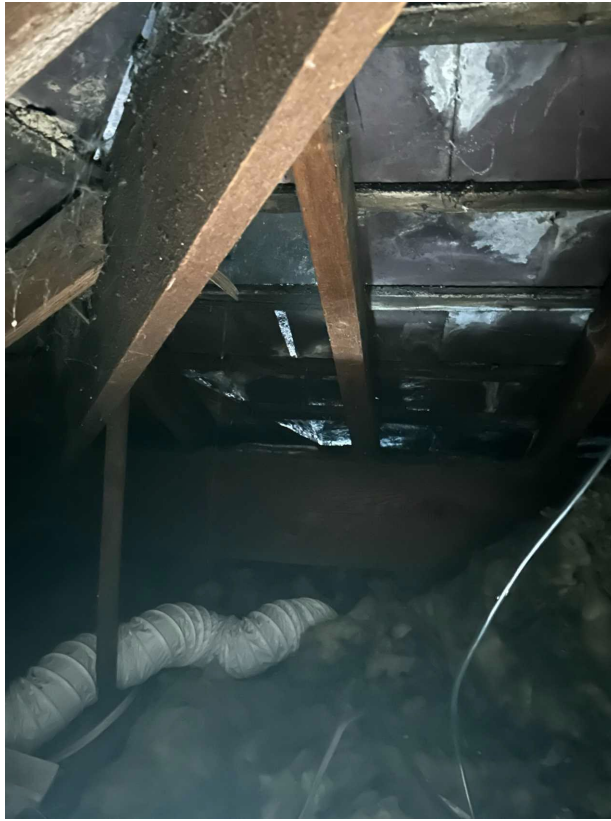
Daylight entry

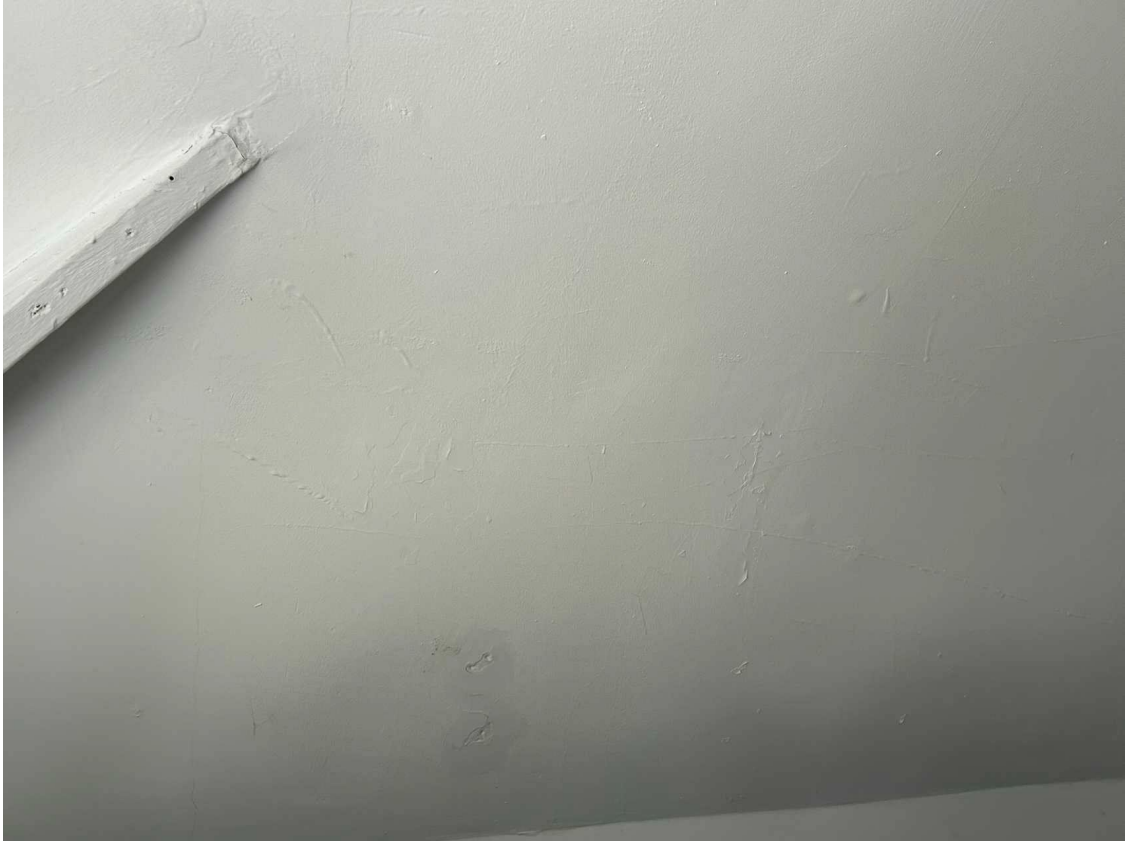
Appears to be a mixture of lath and plaster and plasterboard and skim, all appeared satisfactory. However, we did note a few minor defects, cracking to plaster and patch area as can be seen from the pictures provided. These are minor aesthetic items and can be dealt with and during the next decoration work.

Bedroom 3- rough finish to ceiling

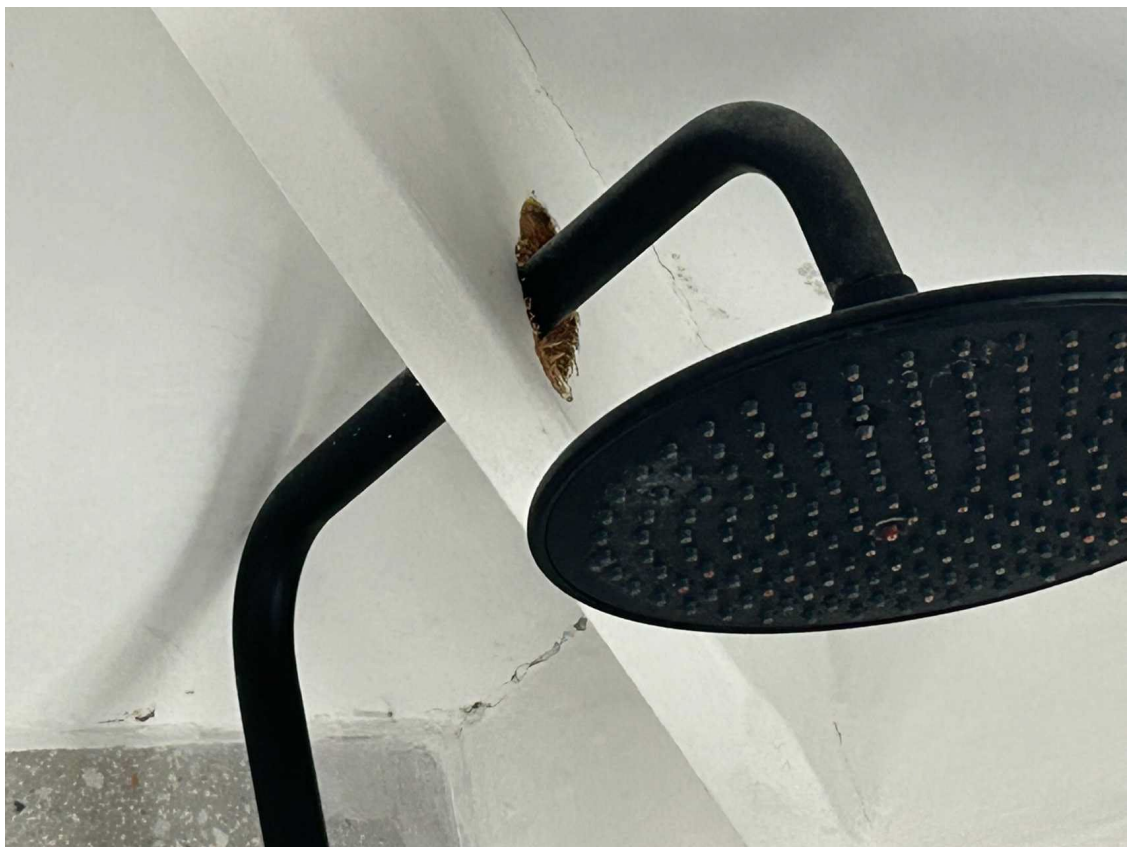
We noted that shower pipe has been installed **through the hip rafter**, requiring part of this key load-bearing timber to be cut away. This weakens the rafter and reduces its ability to support roof loads, increasing the risk of movement, distortion, or future structural failure.

View to shower fitting- hole to hip rafter

A **structural engineer** should assess the extent of the damage. The rafter will likely need **reinforcement (such as sistering or steel plating)**, and the pipework should be **rerouted** so it no longer passes through structural timbers. Any associated moisture damage should also be checked and addressed.

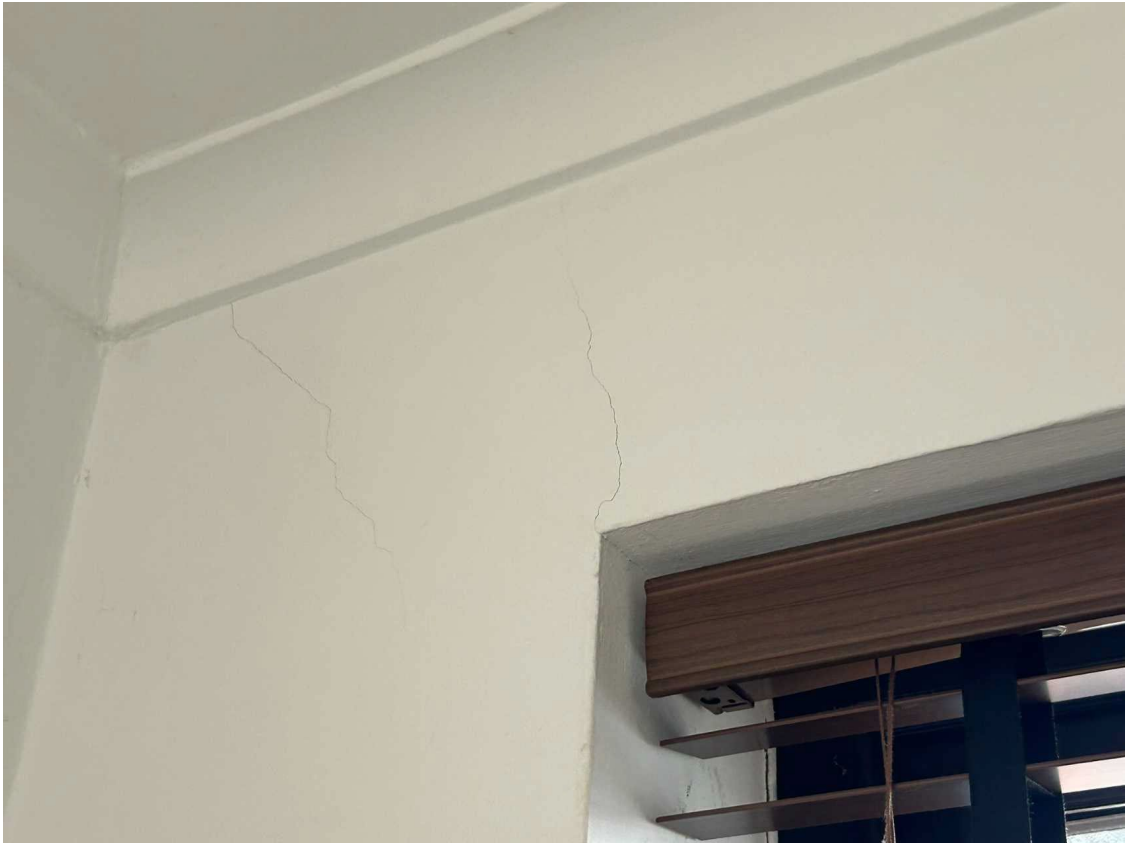
Minor cracking
