LEVEL THREE

Your survey report

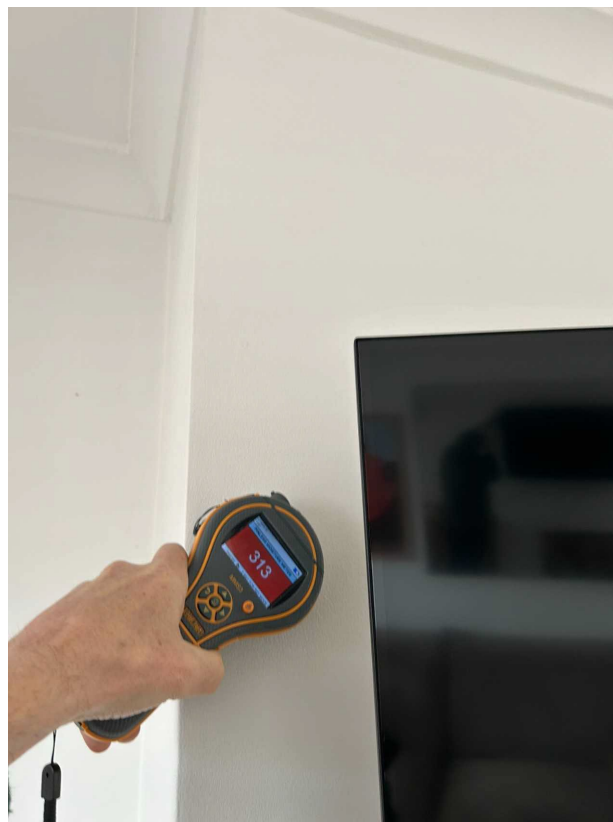
High moisture reading to lounge chimney breast

E5	Fireplaces, chimney breasts and flues	Following repairs to the chimney breast, the affected area should be monitored for any remaining signs of dampness. Once the masonry has dried, the salt-contaminated plaster should be removed and replaced with a suitable renovating plaster designed to resist residual salts..

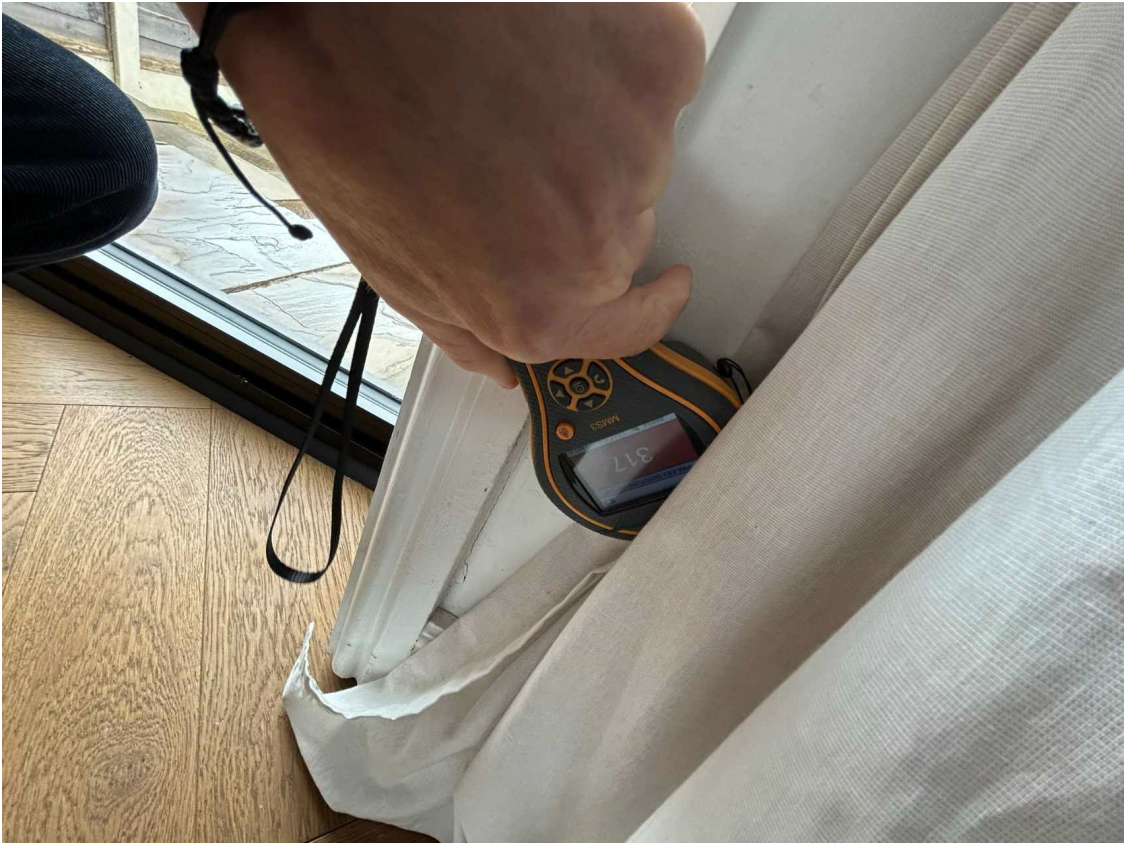
High moisture reading to one side of patio door

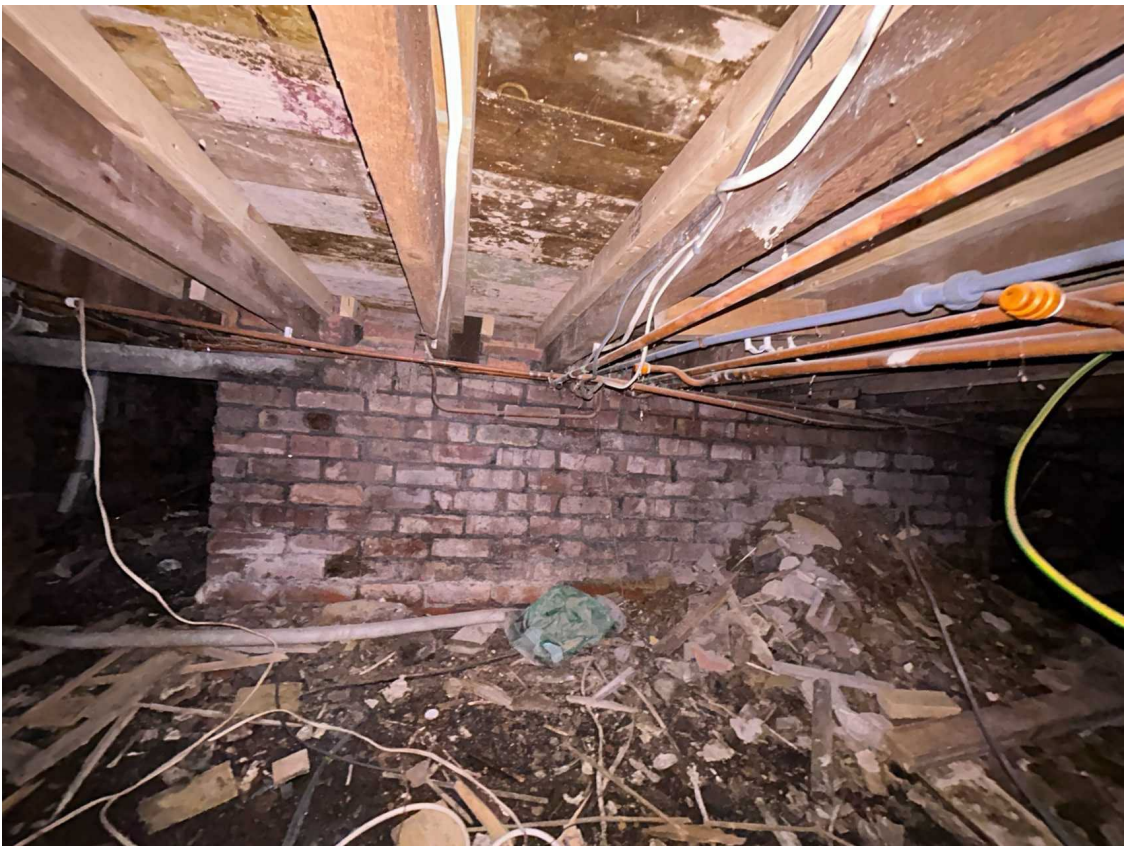
View to floor void- note debris

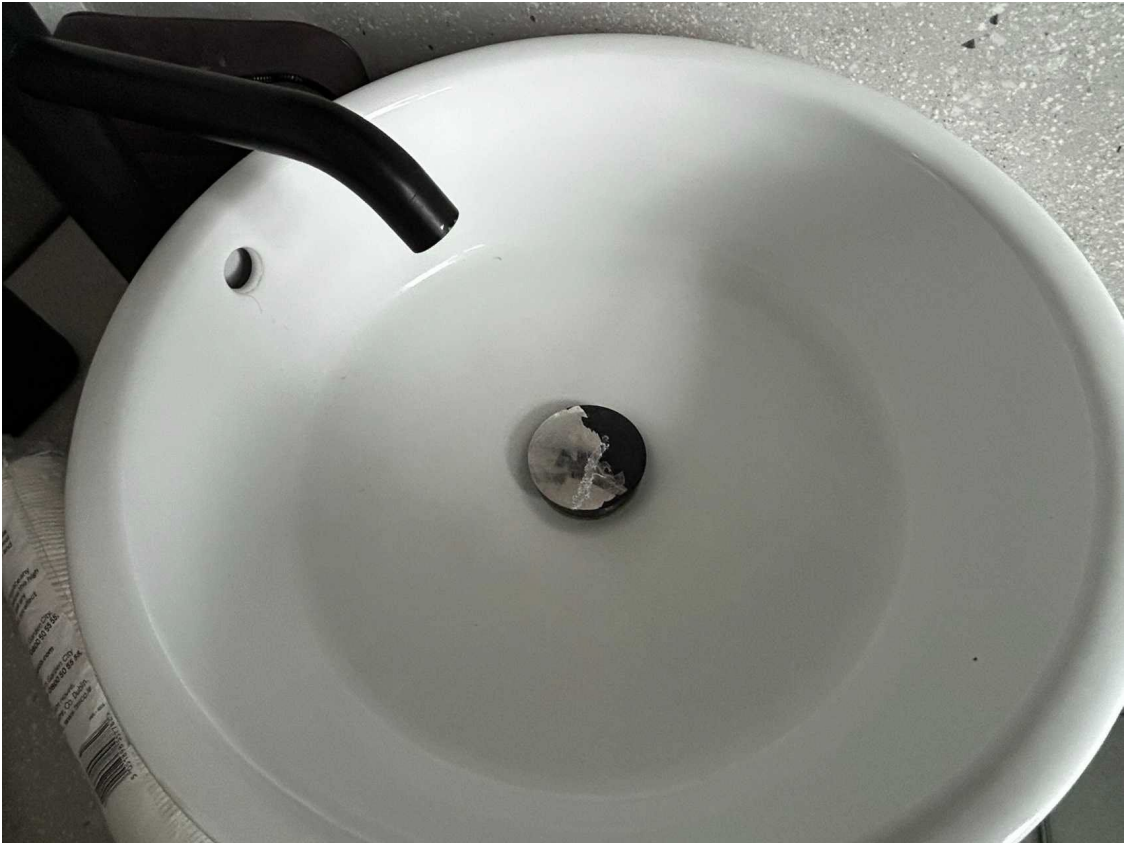
View to the hand basin worn chrome stopper

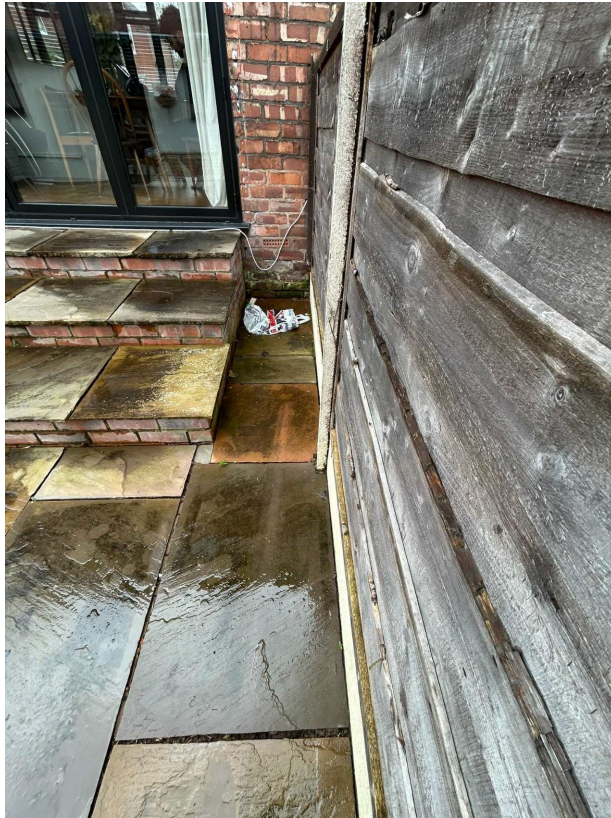
To the rear, the steps leading up to the patio have **interrupted the drainage run**, resulting in **ponding water** against the base of the brickwork. This has caused **staining and discolouration** to the lower brickwork. One of the brick piers is **missing its capping**, leaving the top surface exposed to weathering.

Poor drainage, staining to base of brick

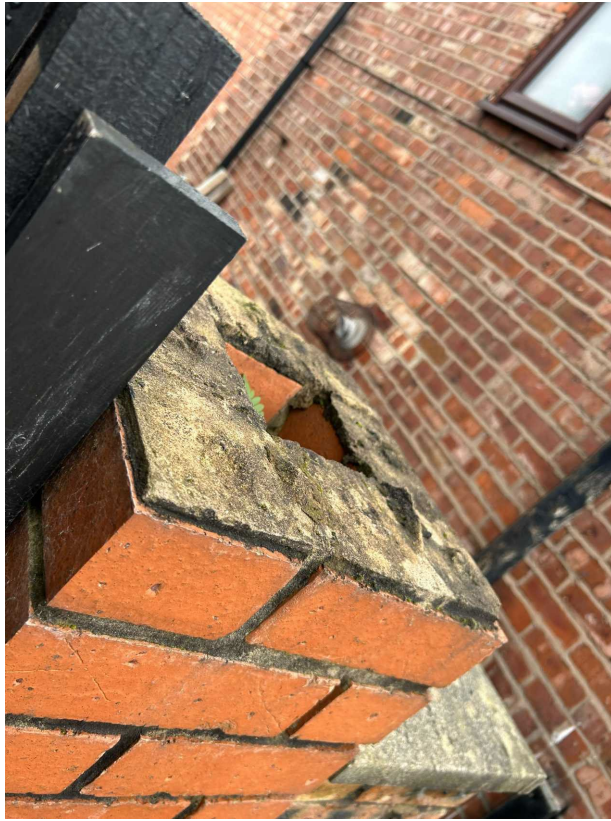
Pier - missing capping

E4	Floors	Carry out localised repairs to the landing floorboards to address the sagging and creaking noted during inspection. Ensure that sub-floor ventilation remains unobstructed, and consider improving underfloor insulation where accessible. If movement persists after minor repairs, have a competent carpenter check the supporting joists and fixings for any signs of deterioration.
G2	Permanent buildings and other structures	Refer to the recommendation in the report.
G3	Other grounds	Improve the rear drainage run to prevent ponding against the brickwork, reinstate a proper fall away from the building, and fit a suitable capping to the exposed brick pier to protect it from further weathering.
