LEVEL THREE

Your survey report

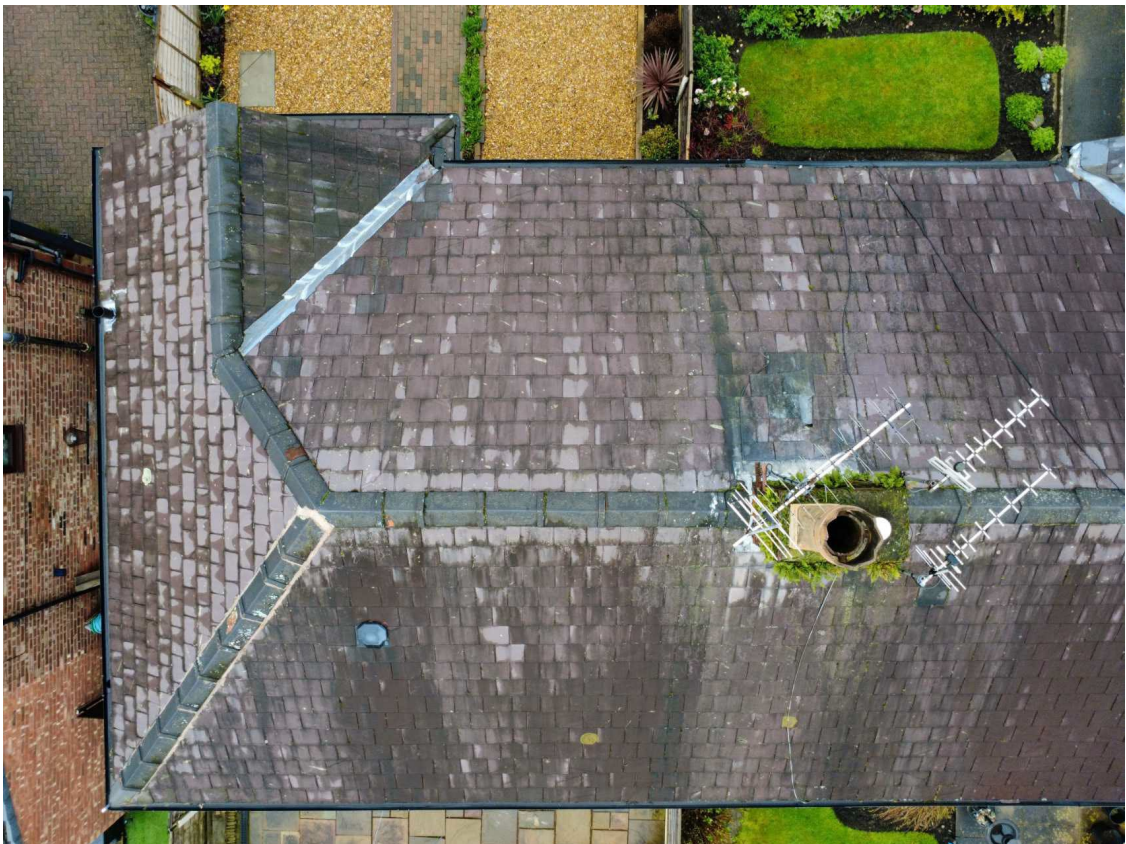
We observed possible slipped/defective slates and mortar pointing on some of the ridge tiles are beginning to erode. We recommend immediate repairs to prevent water ingress, timber decay and dampness. The roof structure is generally performing its function. There is no underfelt; the roof covering appears to be original. We noticed daylight to the front of the roof space, indicating small gaps to the roof covering which will be vulnerable to wind-driven rain penetration. There is no apparent signs of roof leaks.

View to main roof from above

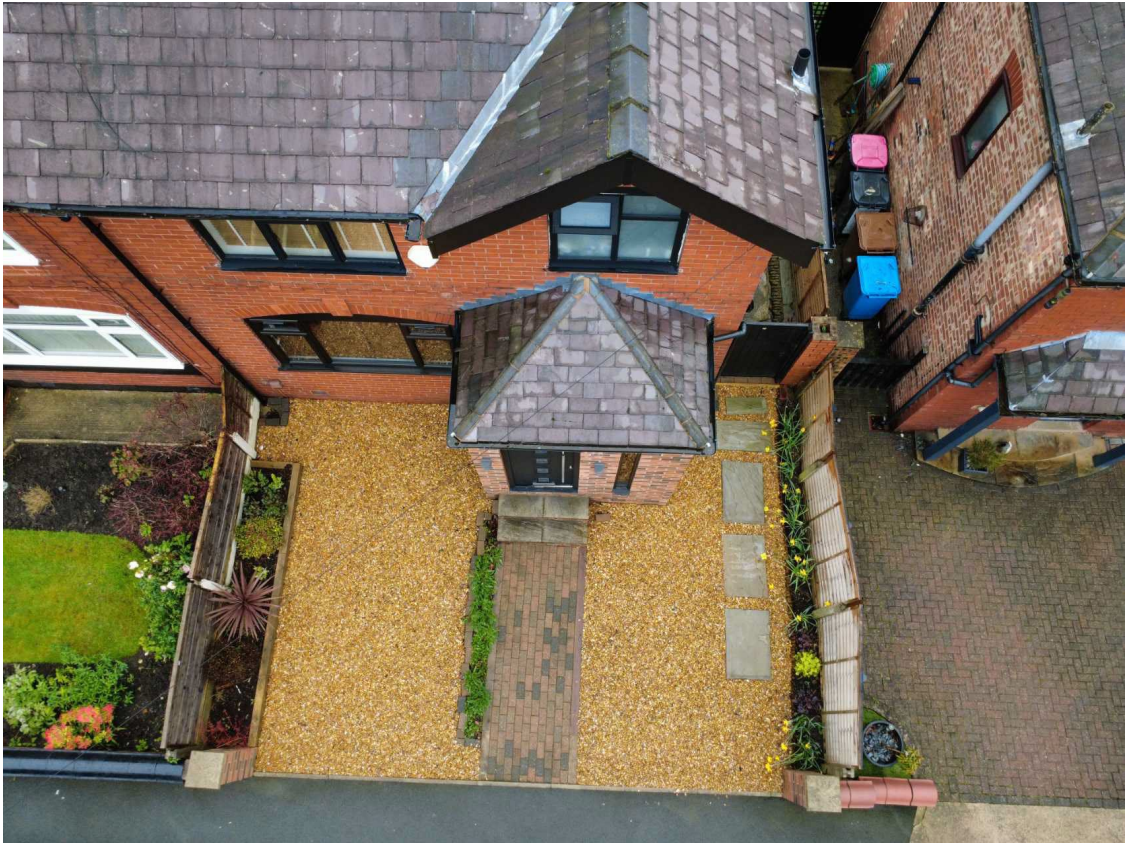
The roof covering to the front porch requires some minor repairs as can be seen from the labelled photos.

View showing the porch roof to the front

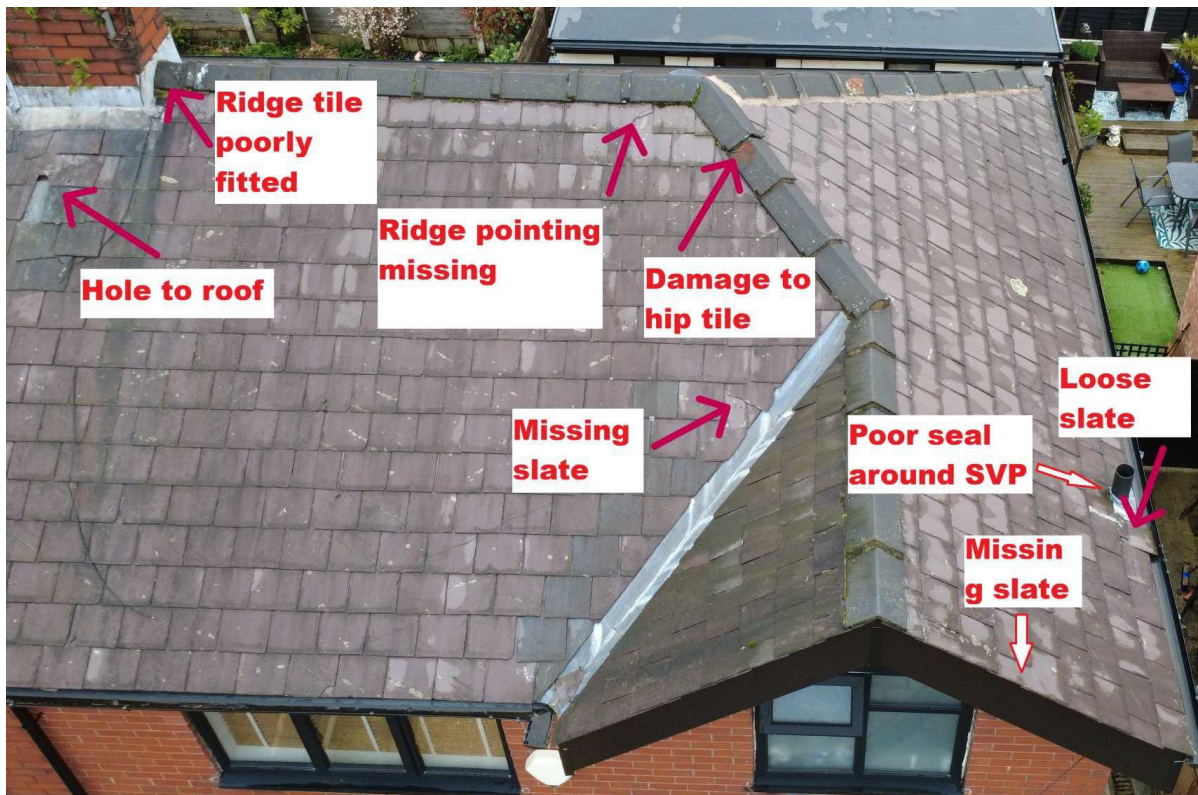
View to main roof from front

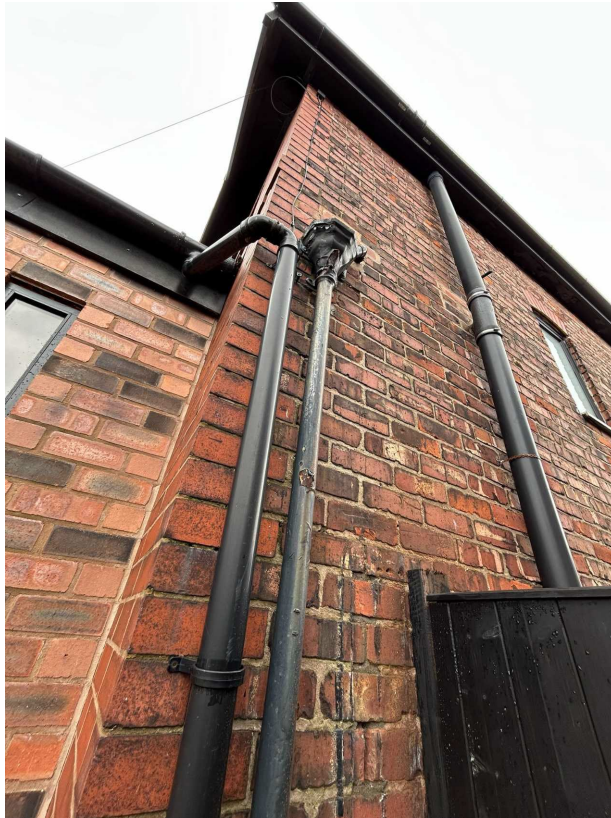
RWP to porch roof

We noted standing water in the guttering at the front of the property, which overflows as evident from the staining on the base of the front wall. There is debris blocking the front rainwater outlet. The porch roof guttering has also poor falls, which is evident by the standing water.

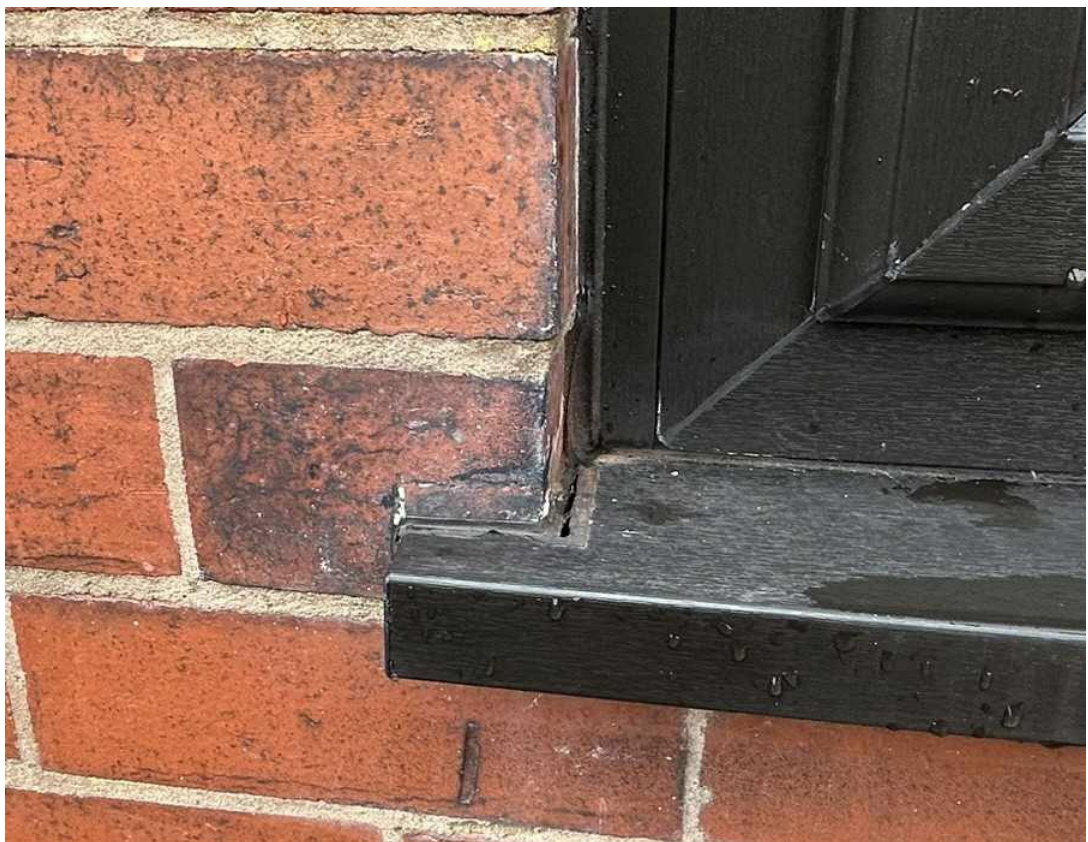
There are gaps to the sealant on the main building and sealant missing to the porch windows. We would recommend that all defective sealant is removed and replaced to prevent water penetration around the frame.

Gap to sealantt- lounge window

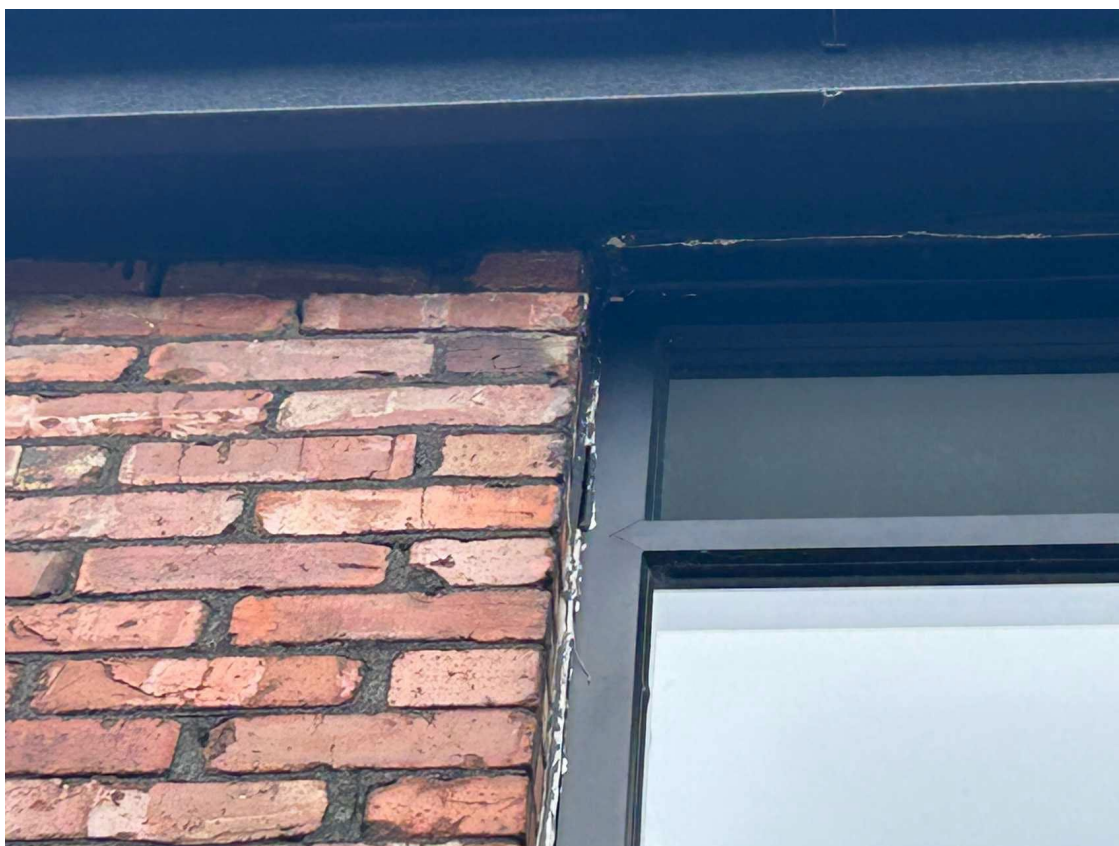
Gaps to sealant- rear windows

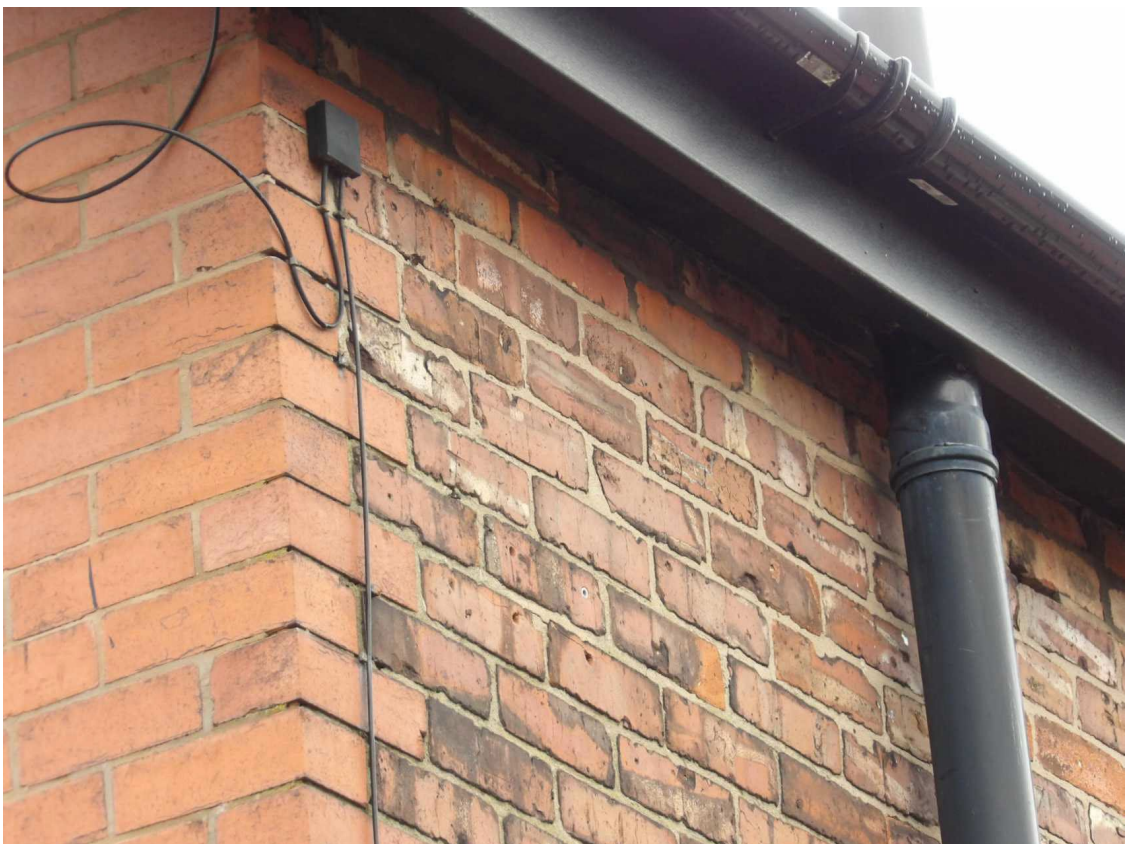
Other joinery includes non-biodegradable materials at the eaves level (the edges of the roof where the guttering is fixed). There is an original soffit (the underside of the roof overhang) to the right-hand elevation, and the paintwork is peeling from the woodwork at the eaves level.

Close-up view of the right hand elevation eaves

External decorations, such as repainting woodwork and inspecting uPVC components for damage, should be carried out as required, about every five years, to ensure that all surfaces are protected.

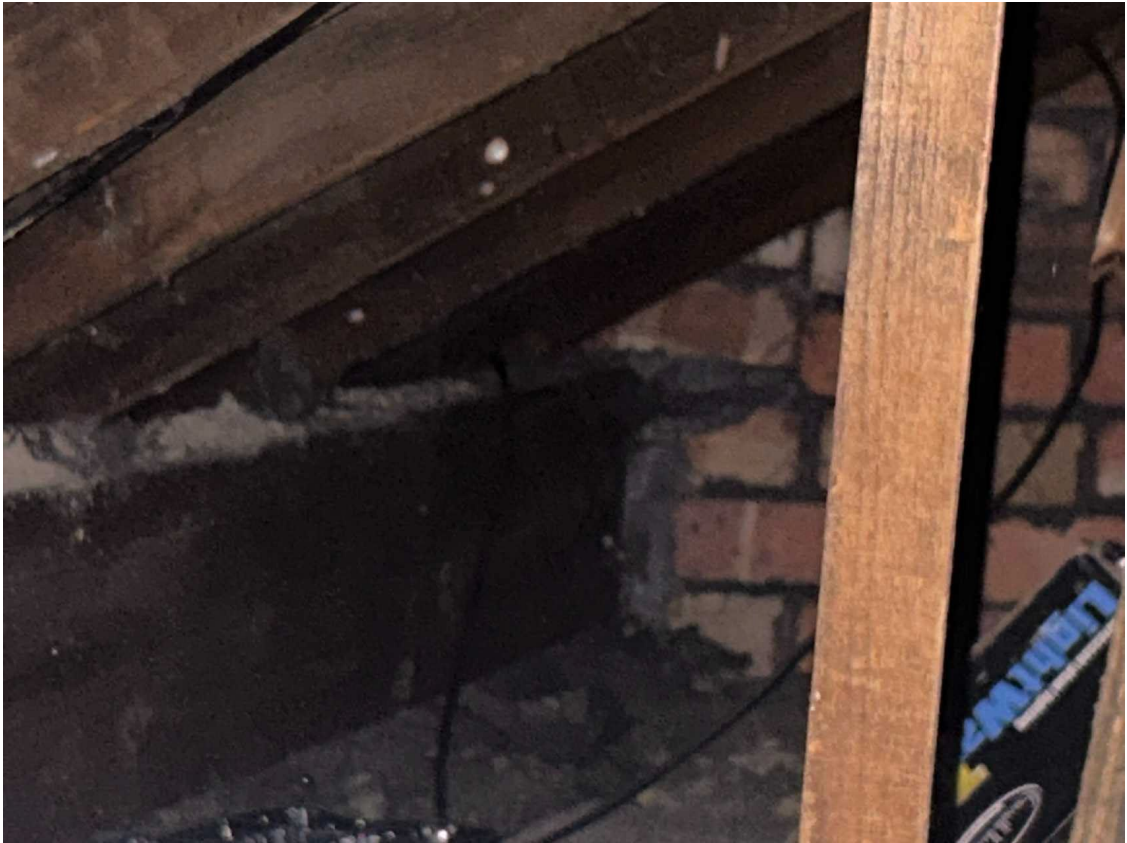
View to purlin support below hole in the roof

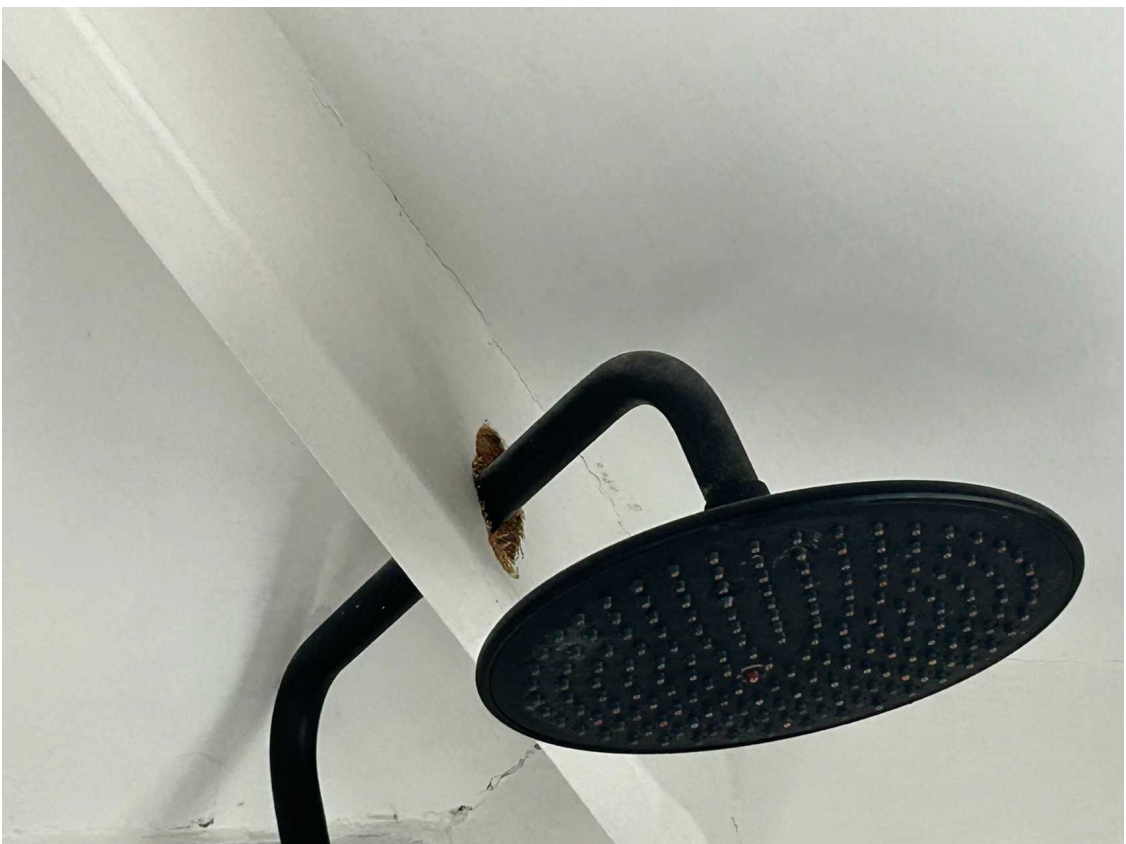
We noted that shower pipe has been installed **through the hip rafter**, requiring part of this key load-bearing timber to be cut away. This weakens the rafter and reduces its ability to support roof loads, increasing the risk of movement, distortion, or future structural failure.

Shower fitting pass through, hip rafter

A **structural engineer** should assess the extent of the damage. The rafter will likely need **reinforcement (such as sistering or steel plating)**, and the pipework should be **rerouted** so it no longer passes through structural timbers. Any associated moisture damage should also be checked and addressed.

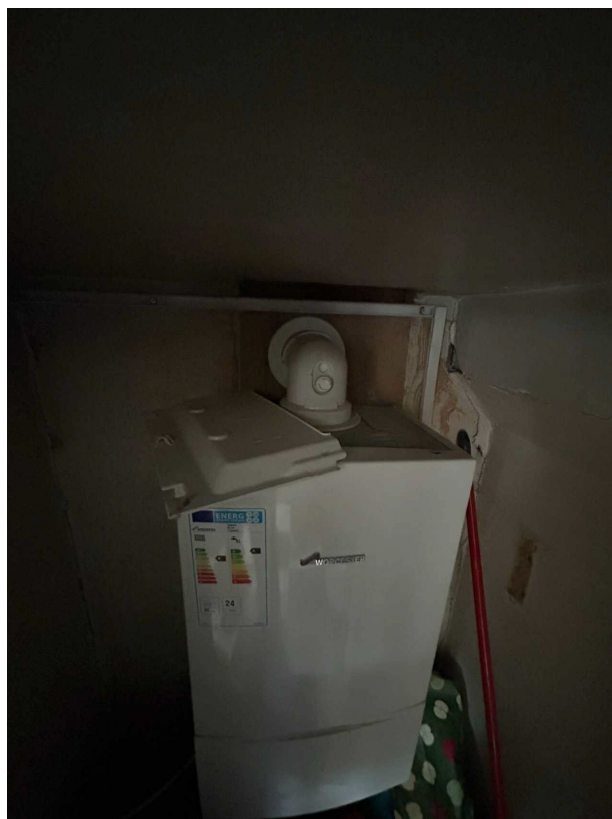
Gas boiler

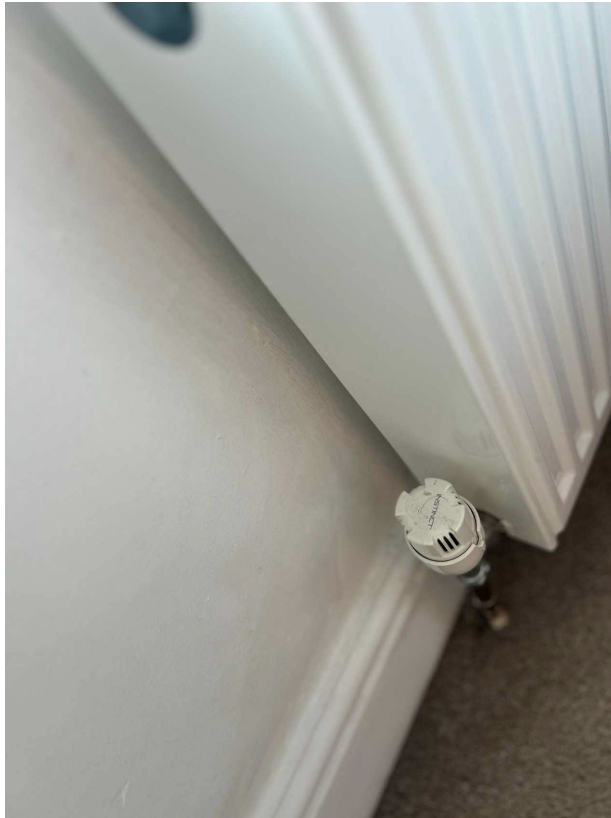
Radiator

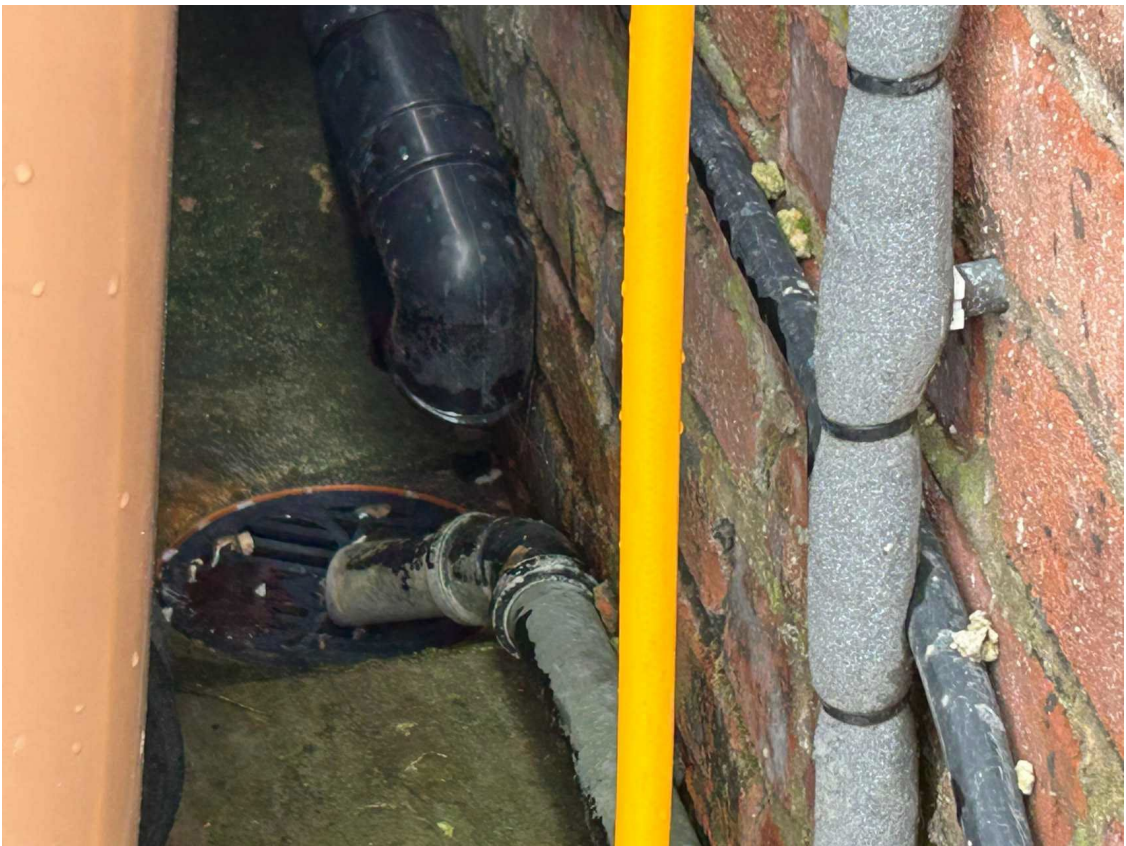
Waste pipes to the gully on the right hand side

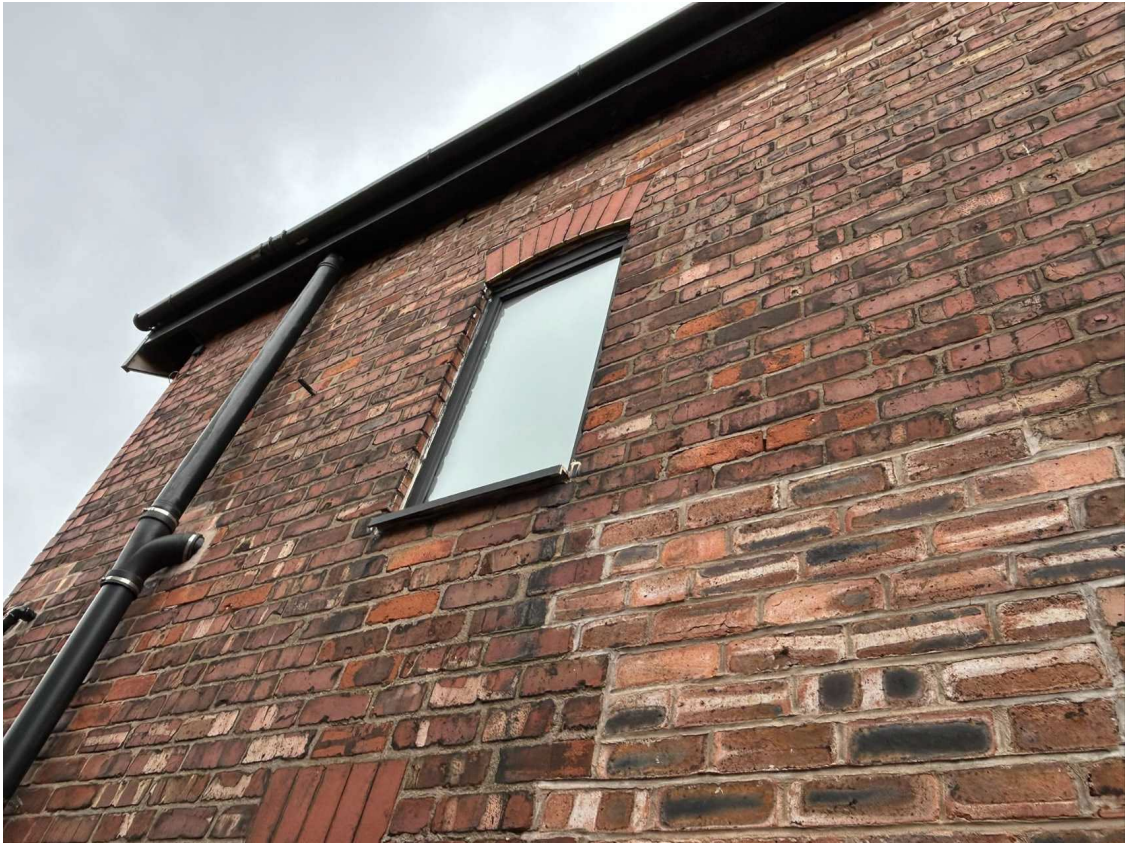
Soil pipe to the right-hand gable

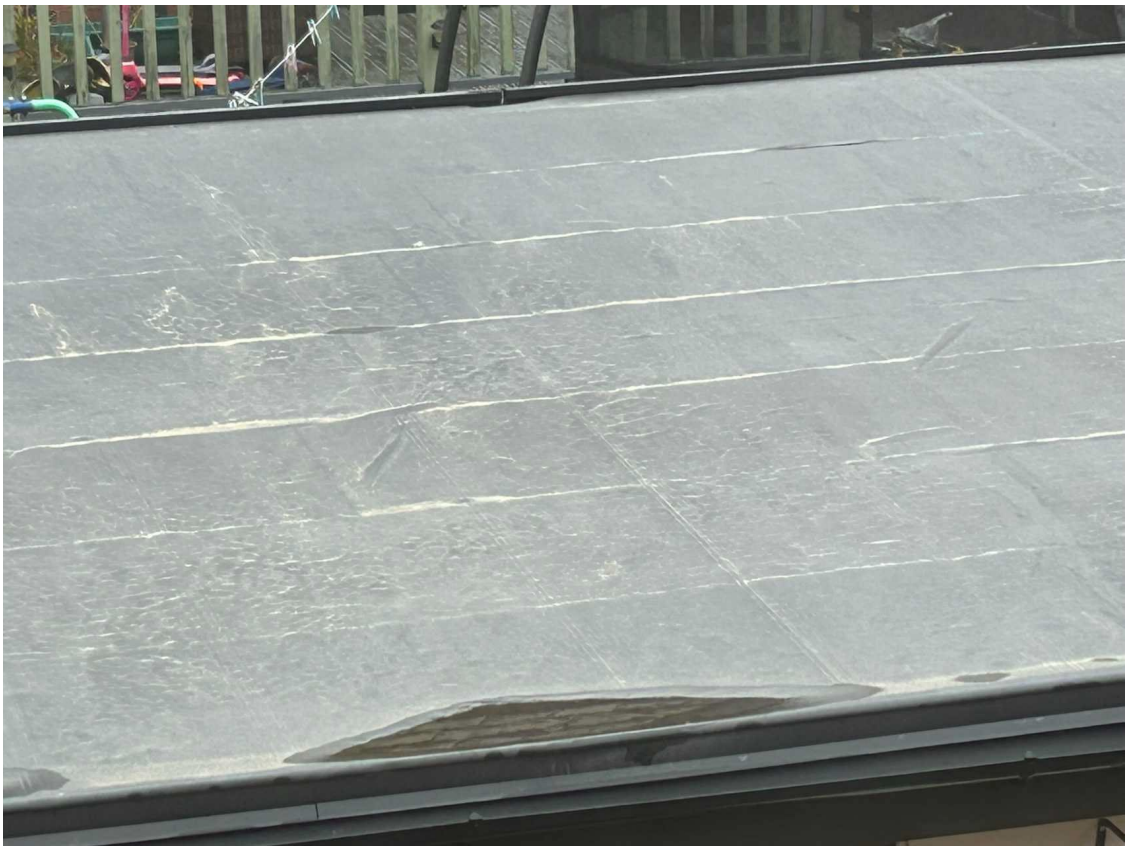
View to flat roof to out building

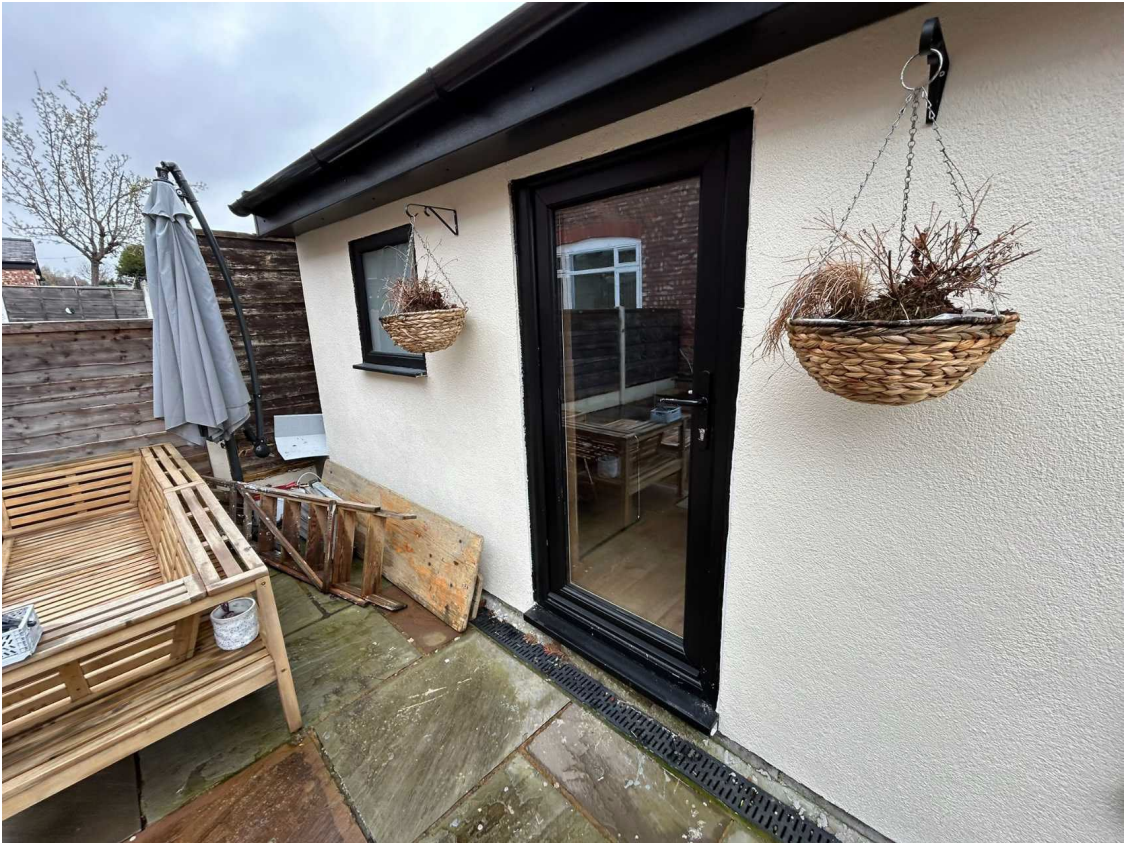
View to front of out-building

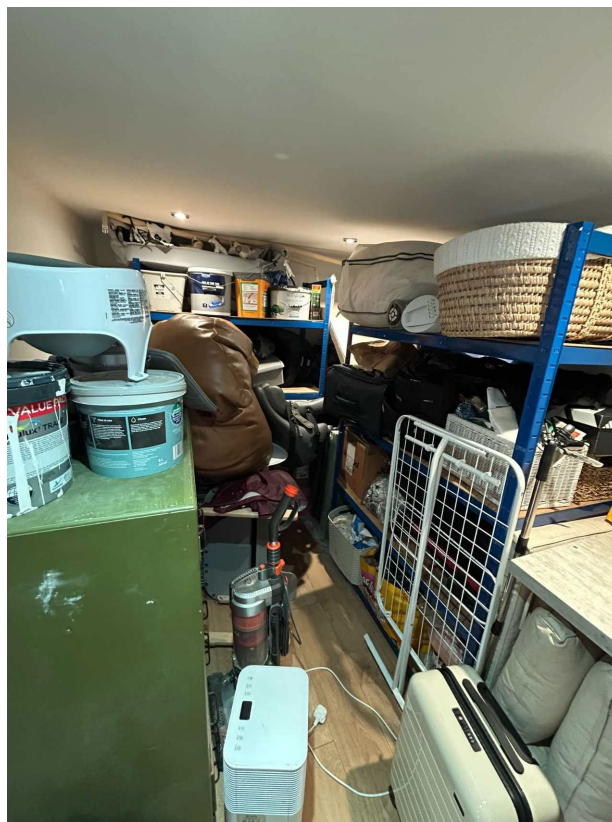
View to utility is in the out building
