LEVEL THREE

Your survey report

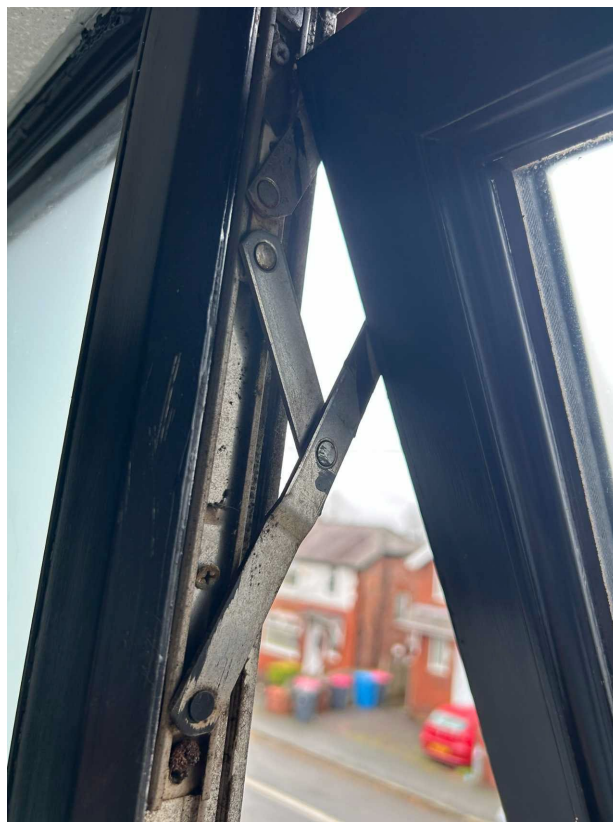
Ironmongery

Windows in the property were opened, and no defects were noted to the operation at the time of inspection. However, we did note some light corrosion to ironmongery. We would recommend that the ironmongery is overhauled.

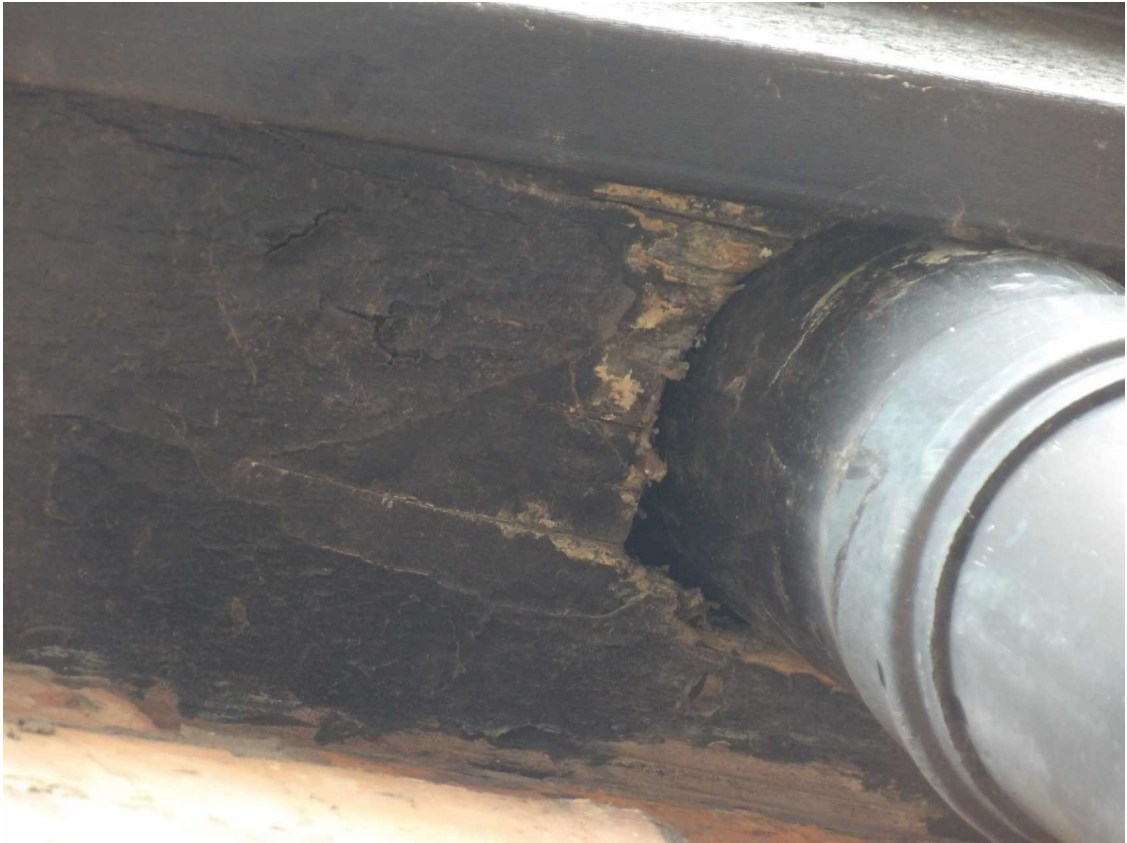
Other joinery includes non-biodegradable materials at the eaves level (the edges of the roof where the guttering is fixed). There is an original soffit (the underside of the roof overhang) to the right-hand elevation, and the paintwork is peeling from the woodwork at the eaves level.

View to soffit to right hand side, around SVP

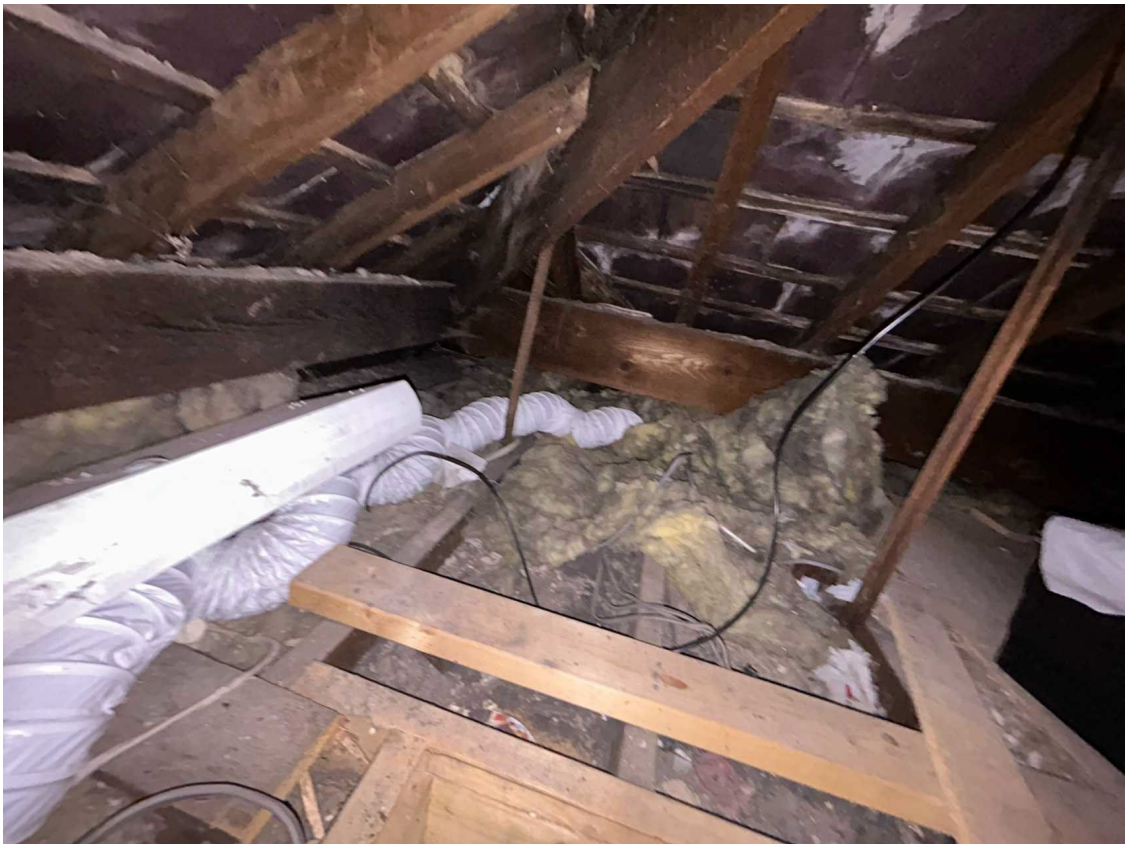
We noted that shower pipe has been installed **through the hip rafter**, requiring part of this key load-bearing timber to be cut away. This weakens the rafter and reduces its ability to support roof loads, increasing the risk of movement, distortion, or future structural failure.

View to front, hip rafter.

A **structural engineer** should assess the extent of the damage. The rafter will likely need **reinforcement (such as sistering or steel plating)**, and the pipework should be **rerouted** so it no longer passes through structural timbers. Any associated moisture damage should also be checked and addressed.

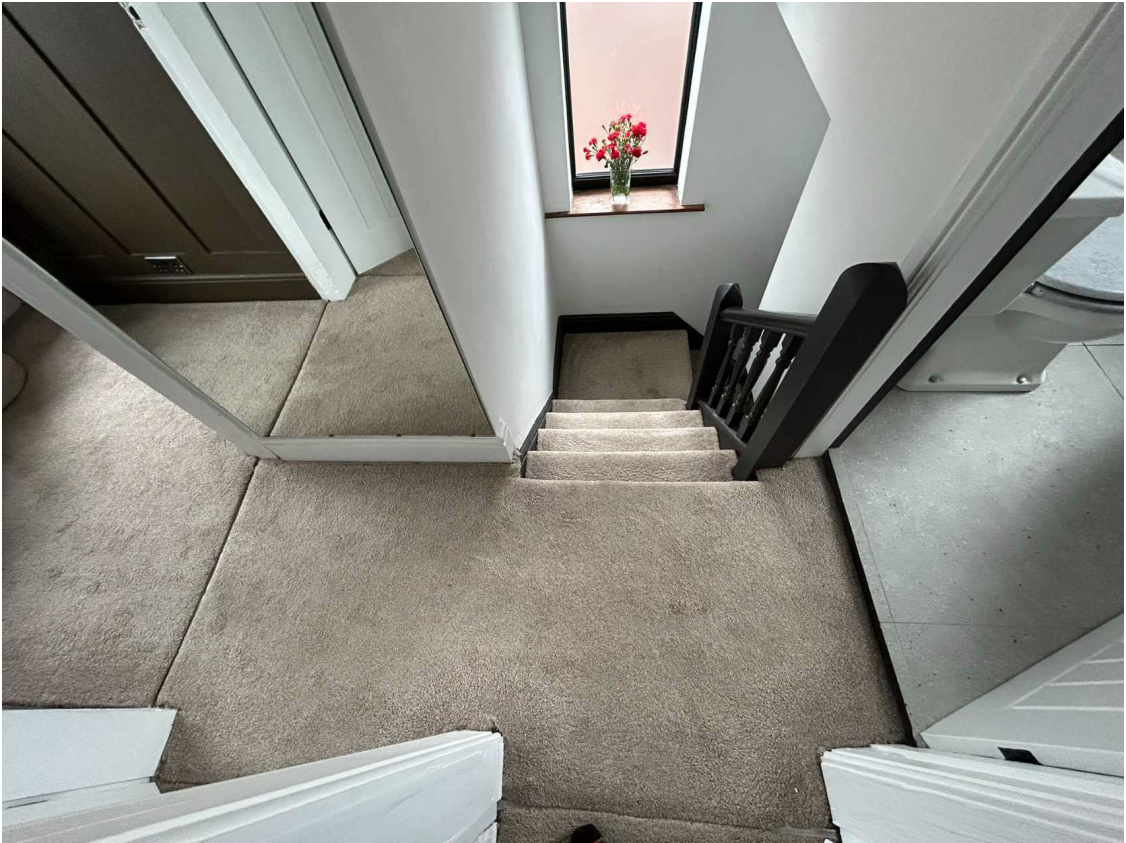
Some localised sagging and creaking was noted to the landing, suggesting loose or weakened floorboards. Minor repairs are recommended, and ventilation to the sub-floor should be maintained to prevent future moisture-related issues.

View to landing

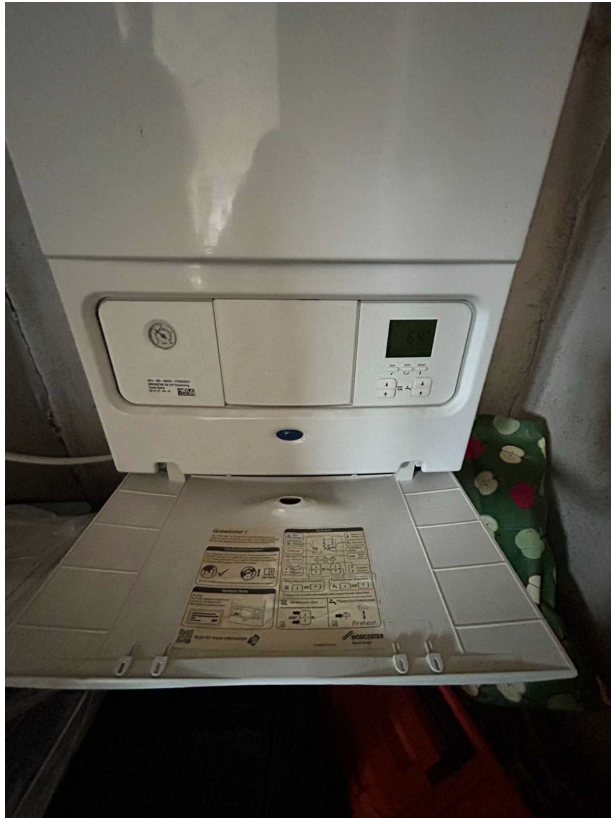
Flue to boiler

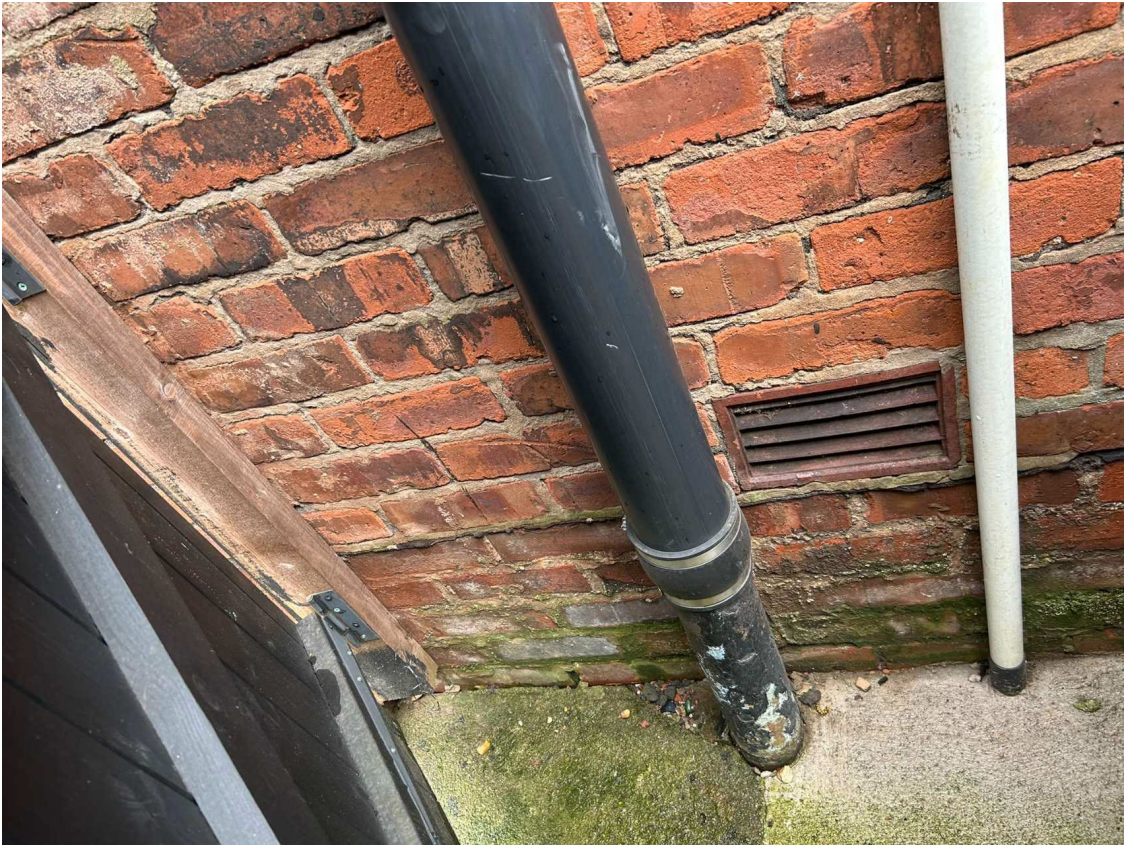
Soil pipe

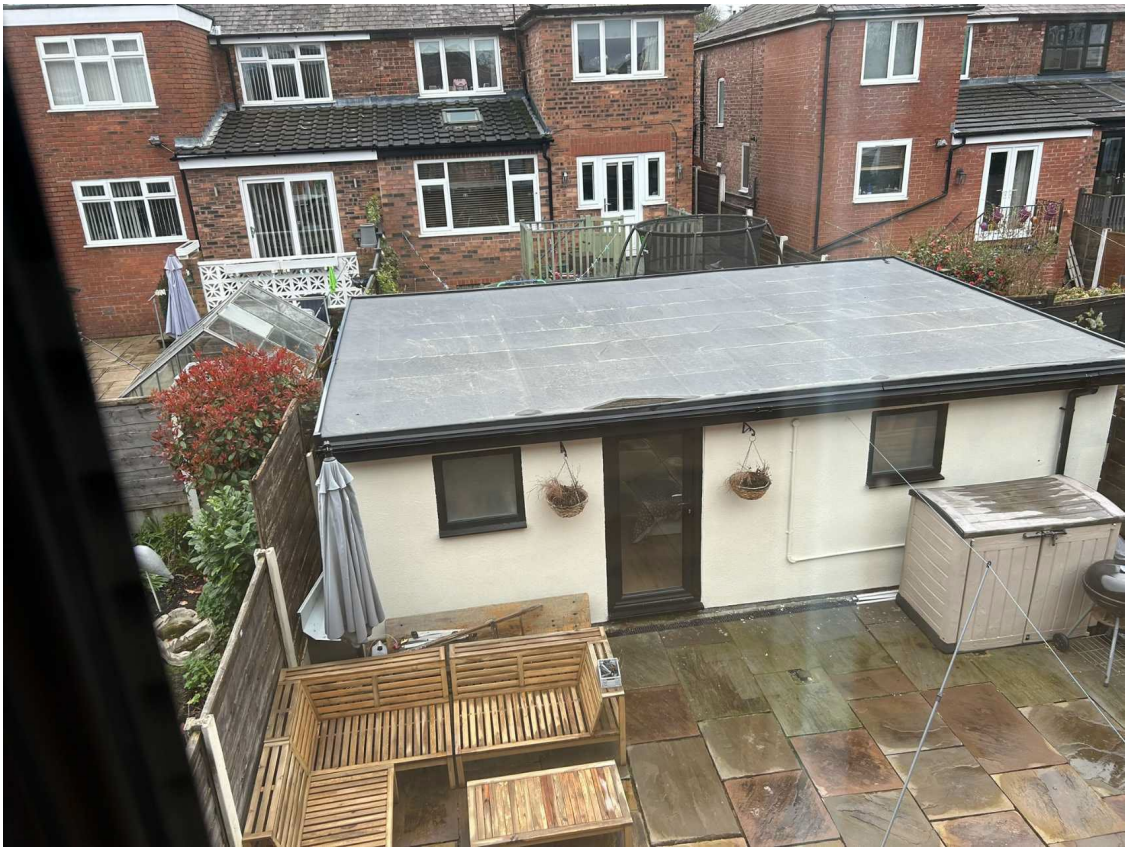
The outbuilding is constructed in single-skin blockwork, offering limited thermal performance and poor resistance to moisture penetration. This form of construction does not comply with current Building Regulations for habitable accommodation, particularly in relation to thermal efficiency, damp-proofing, and structural robustness.

View rear out building

If you intend to upgrade the building for habitable use, you should obtain advice from a qualified builder and Building Control regarding required improvements, including:

- full insulation and damp-proofing
- improved wall construction or internal lining
- installation of a compliant heating system
- ventilation upgrades
- compliance checks for electrical and plumbing installations
- Have the existing electrical installation inspected and tested by a competent electrician to ensure it is safe for continued use in an unheated environment.
- Monitor the building for signs of dampness, condensation or thermal inefficiency, particularly during colder months.

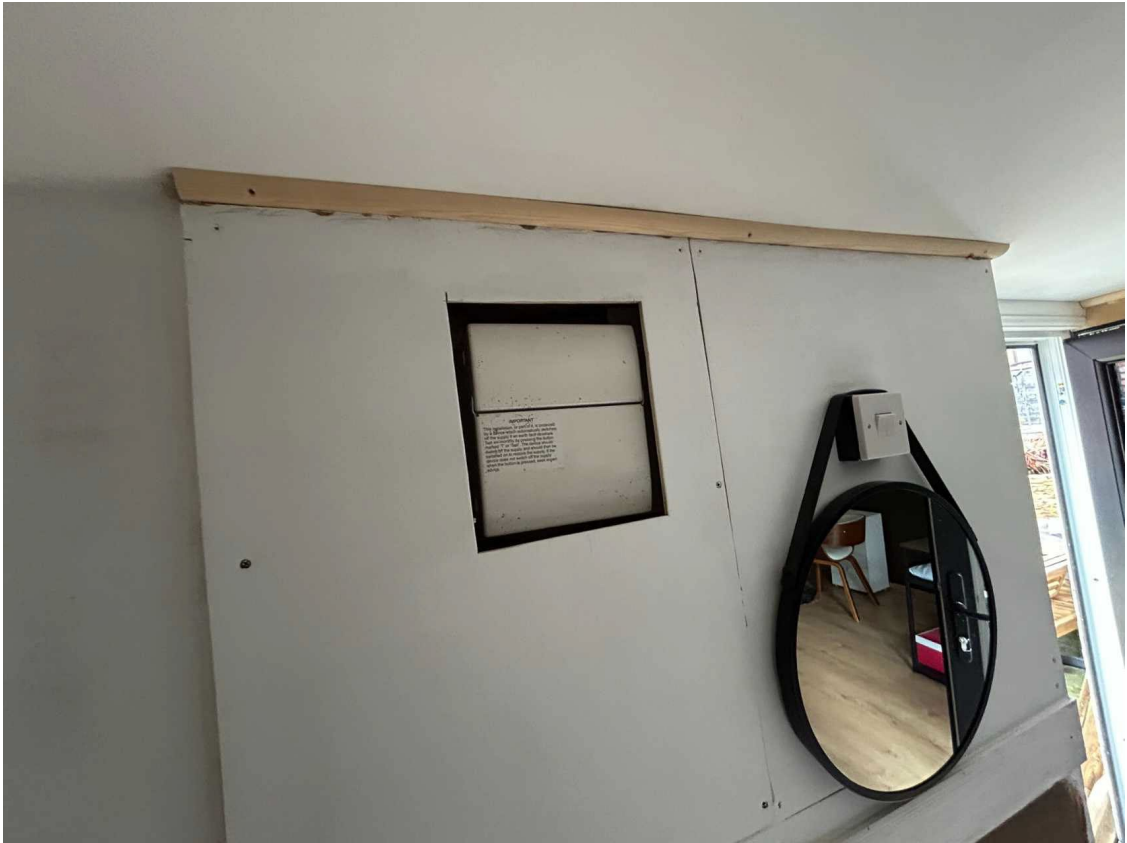
Electrical and plumbing installations in a non-habitable, unheated structure may be at increased risk of condensation-related deterioration.

View to electric consumer unit

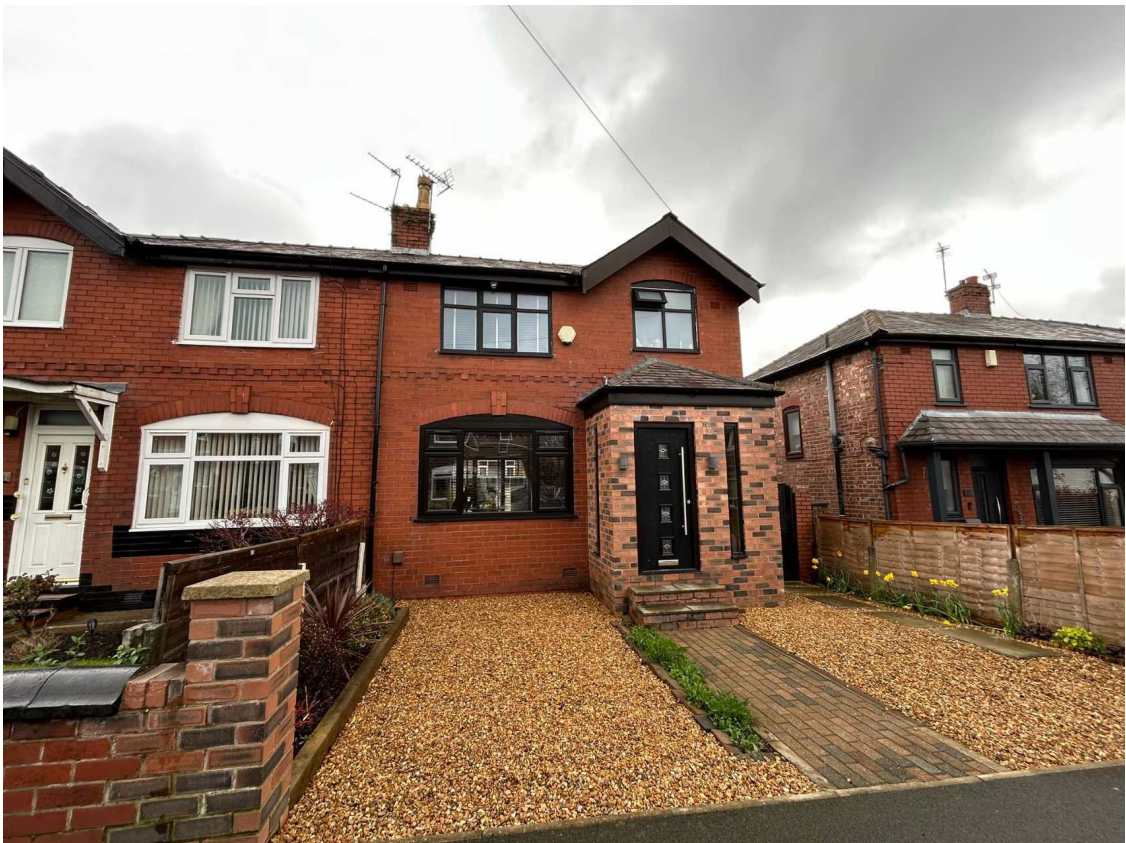
The front and rear yards are laid with gravel and paving, with boundaries formed by **timber posts and timber fence panels**. A paved pathway runs along the **right-hand side** of the property and provides access to the rear.

Front yard

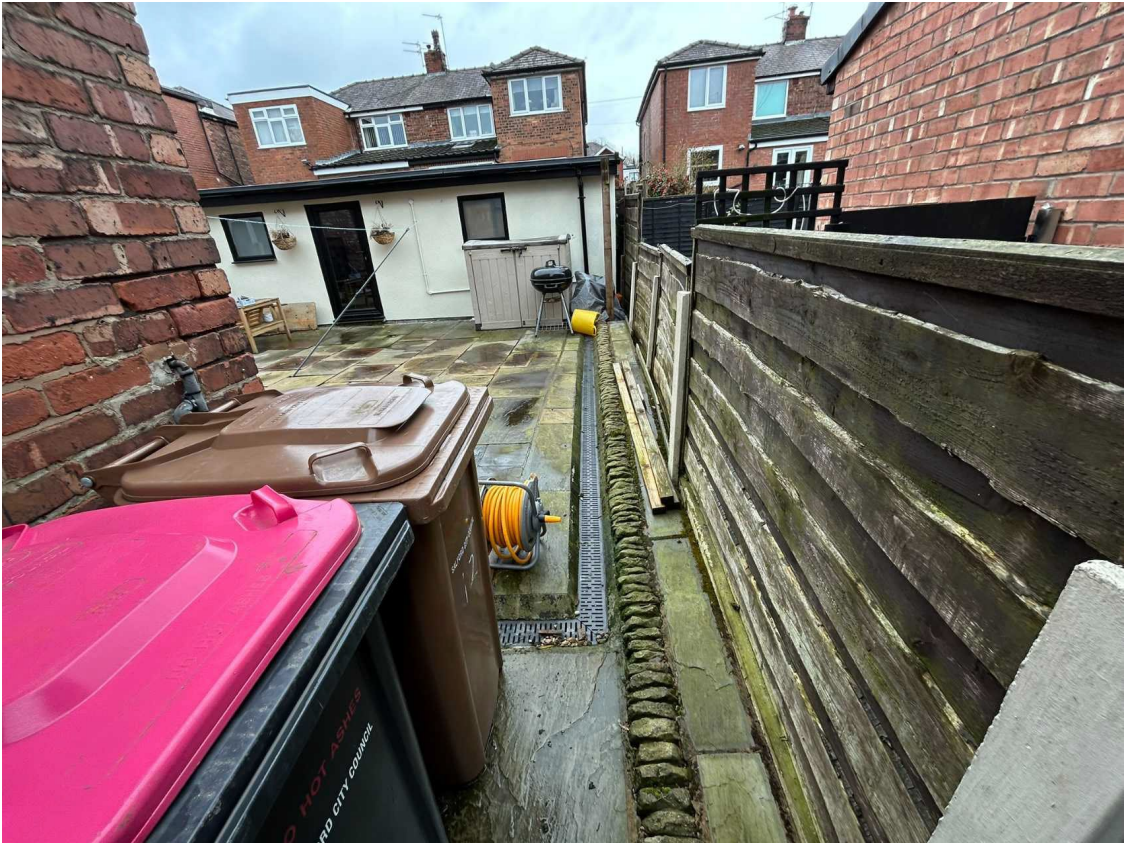
Boundary fence

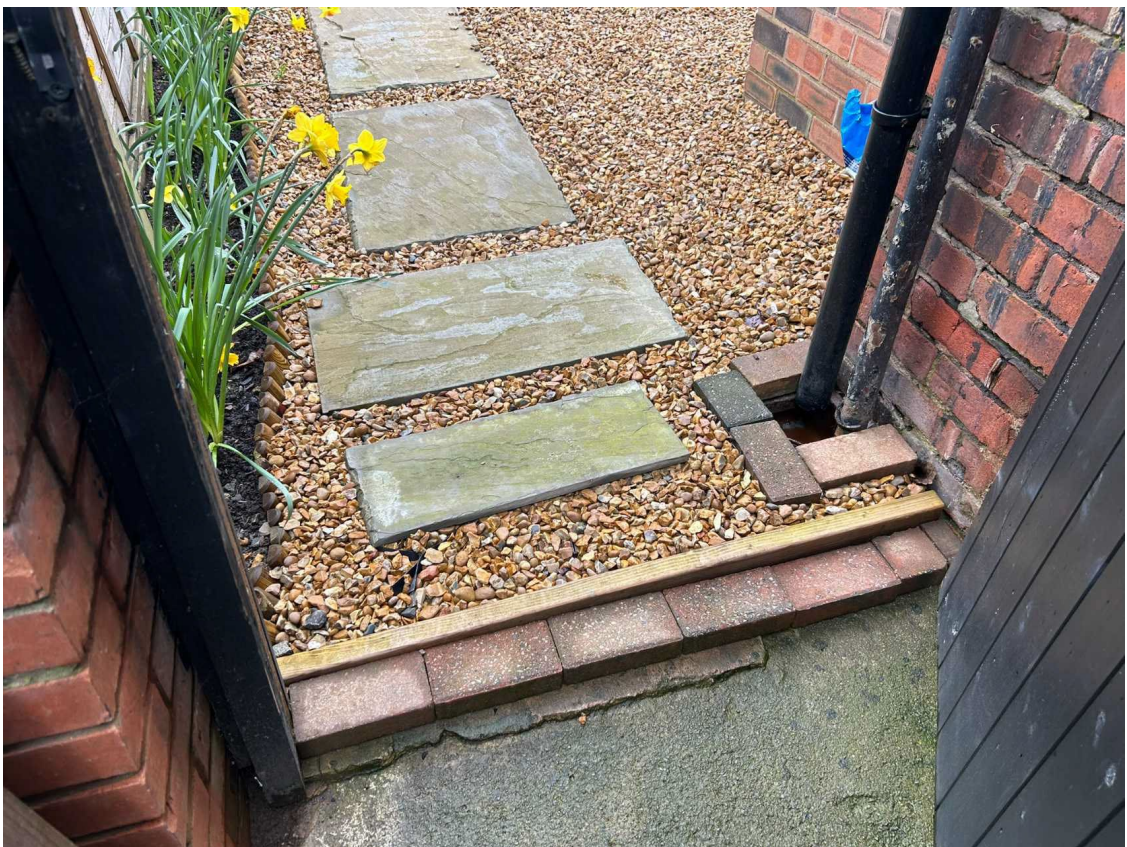
Gate threshold
